# **COMPREHENSIVE NEEDS ASSESSMENT**

**ABLE Apartments  
1000 Any Street  
Atlanta, Georgia**

**ALCA Associates  
520 South State Street  
Westerville, OH 43081  
Office: (614) 794-4900**

**XYZ Companies**

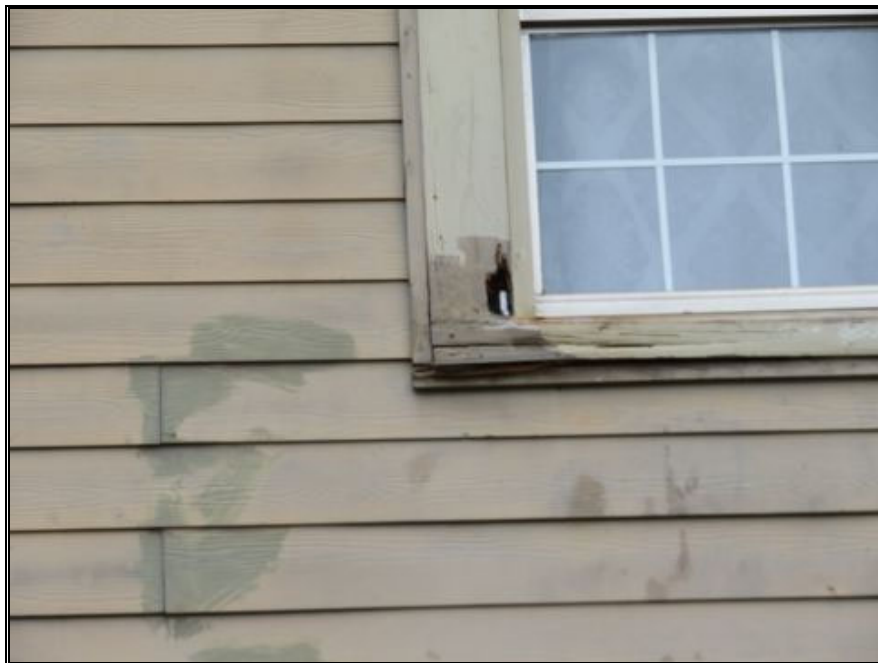
Fascia is metal in generally fair to poor condition. The wooden frames around the windows were reported as leaking into walls.

**P20-Example of Dry Rot on Window Framing**

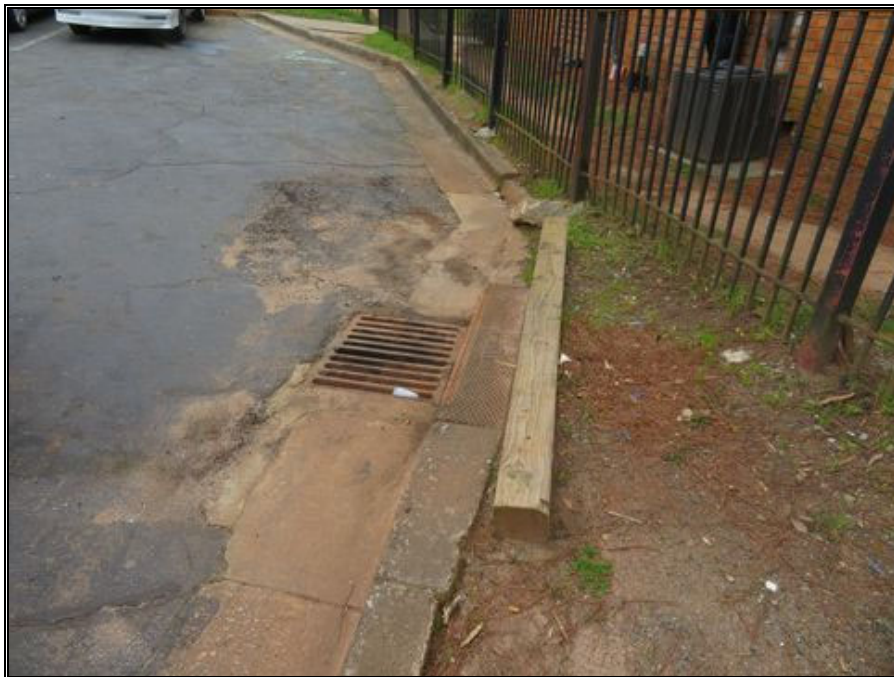
**P24-Typical Condition of Curb Drains**

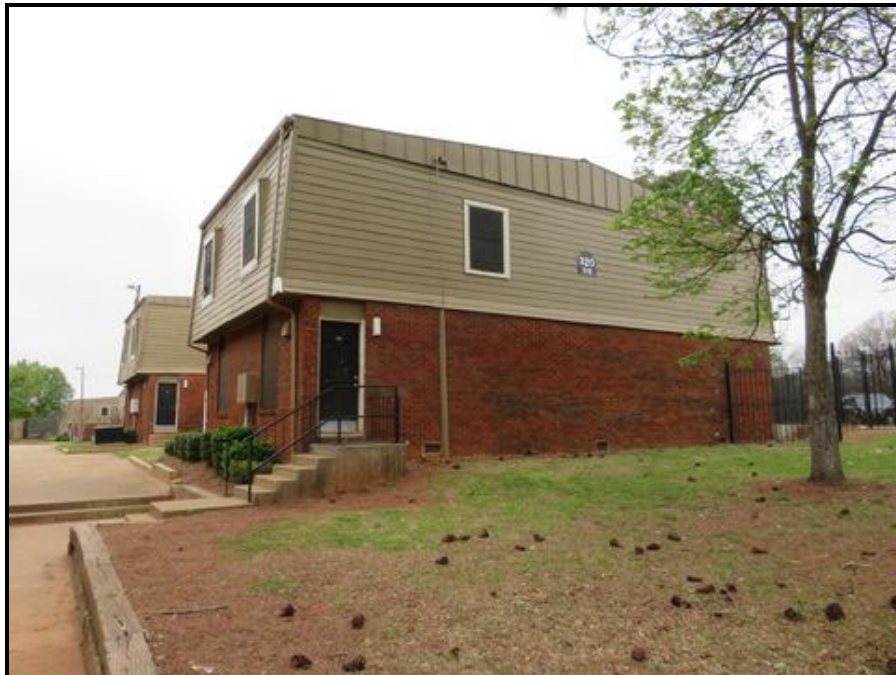
Landscaping appeared in fair condition in front of buildings. There are significant areas of erosion on the property.

**P43-Example of Erosion on the Property**

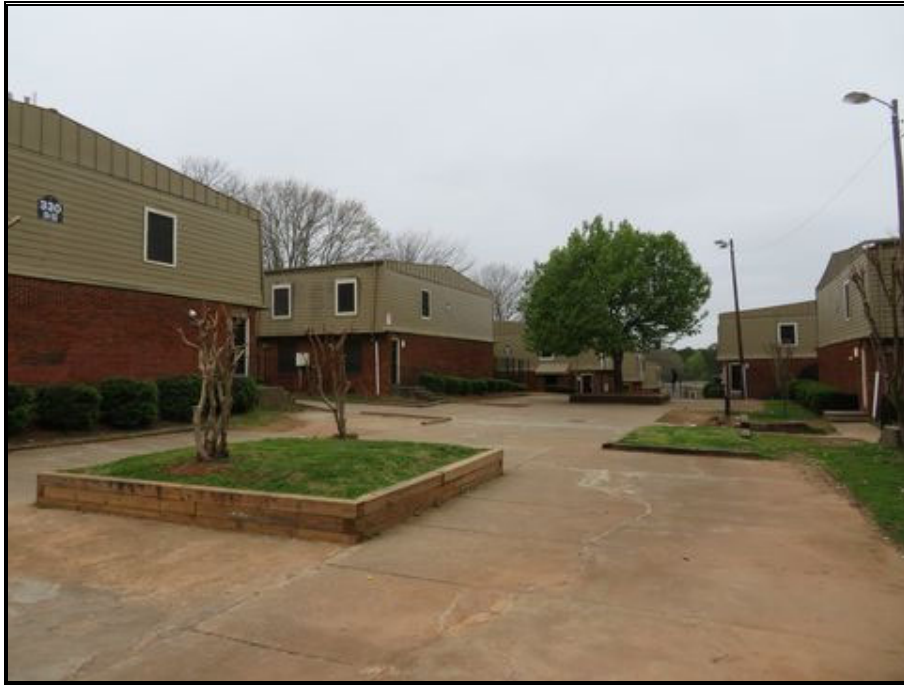
**P46-Concrete Cracking**

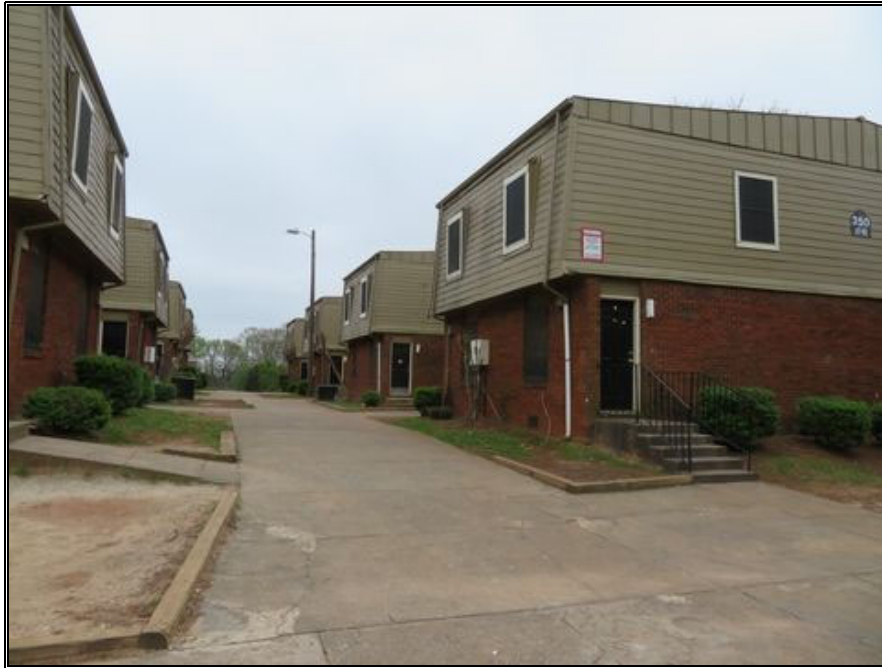
To our knowledge, code-compliant fire walls or smoke chambers are not present or are minimal. Many of the buildings step down with 2 townhouses per terrace. On the largest buildings we observed what appeared to be a parapet fire wall rising above the roof line (based on exterior observation) separating 10-unit buildings into 4-unit and 6-unit apartment groups and 14-unit buildings into 6-unit and 8-unit apartment groups. If this is the situation, then the fire wall/smoke chamber configurations will not meet current code. The architect will need to verify compliance with applicable current codes.

**P48-Building (Fire Wall in Middle)**

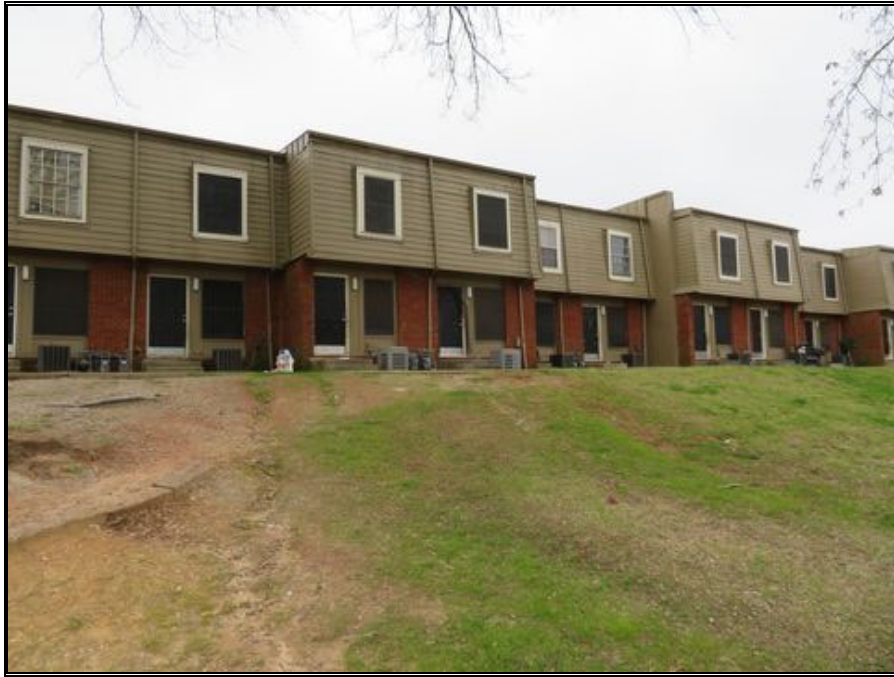
The drainage system is old and inadequate. There are areas of erosion. We were informed that the system is sometimes overwhelmed in a heavy rain.

**P50-Drainage Sluiceway in Front of Buildings**

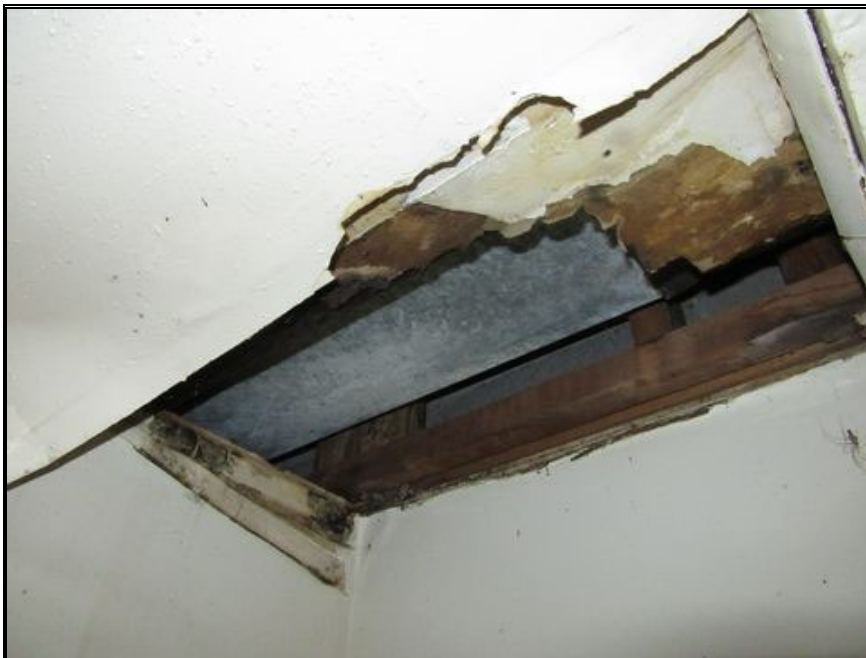
We observed leaking faucets and plumbing (under kitchen and bathroom sinks and through ceilings from upstairs tubs). One apartment had water leaking into a downstairs closet which was a long-term issue creating potential mold conditions. These situations were present in at least 10% to 20% of inspected apartments.

**P91-Mildew in Closet**
