# **COMPREHENSIVE NEEDS ASSESSMENT**

**ABLE Apartments  
1000 Any Street  
Atlanta, Georgia**

**ALCA Associates  
520 South State Street  
Westerville, OH 43081  
Office: (614) 794-4900**

**XYZ Companies**

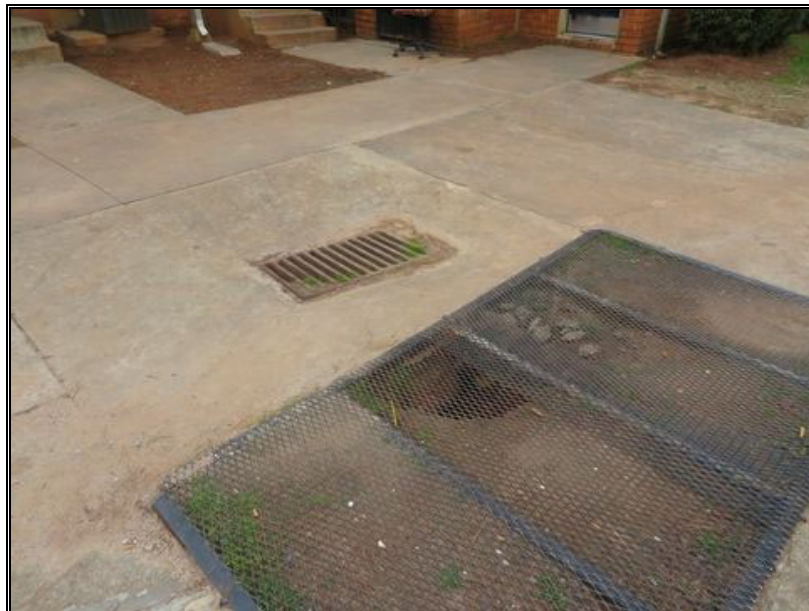
**P8-Sidewalk Storm Water Drain**

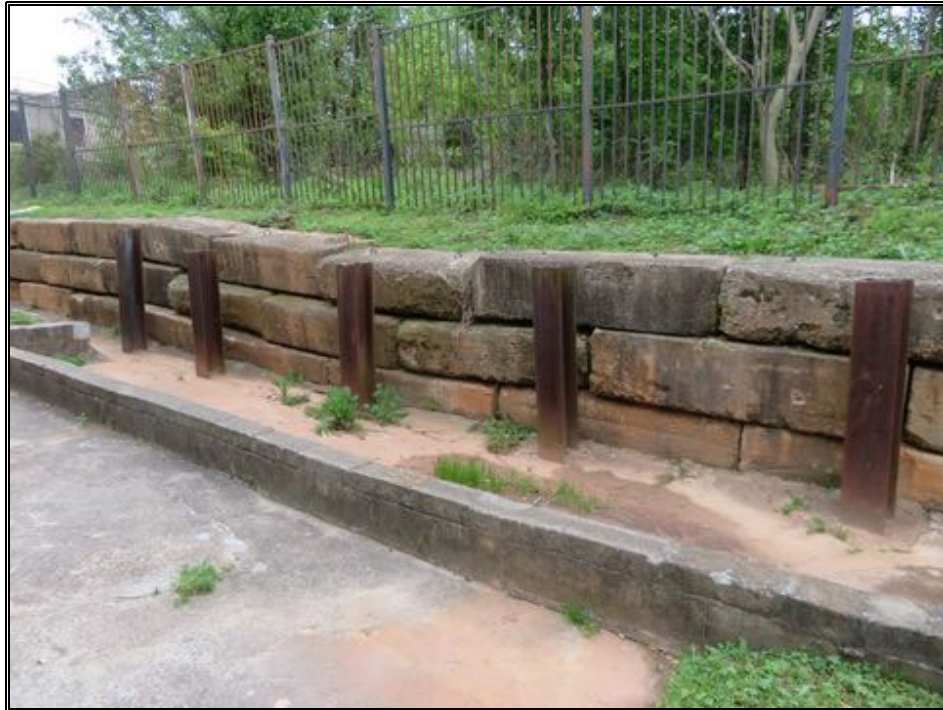
**P9-Block Retaining Wall and Iron Fencing**

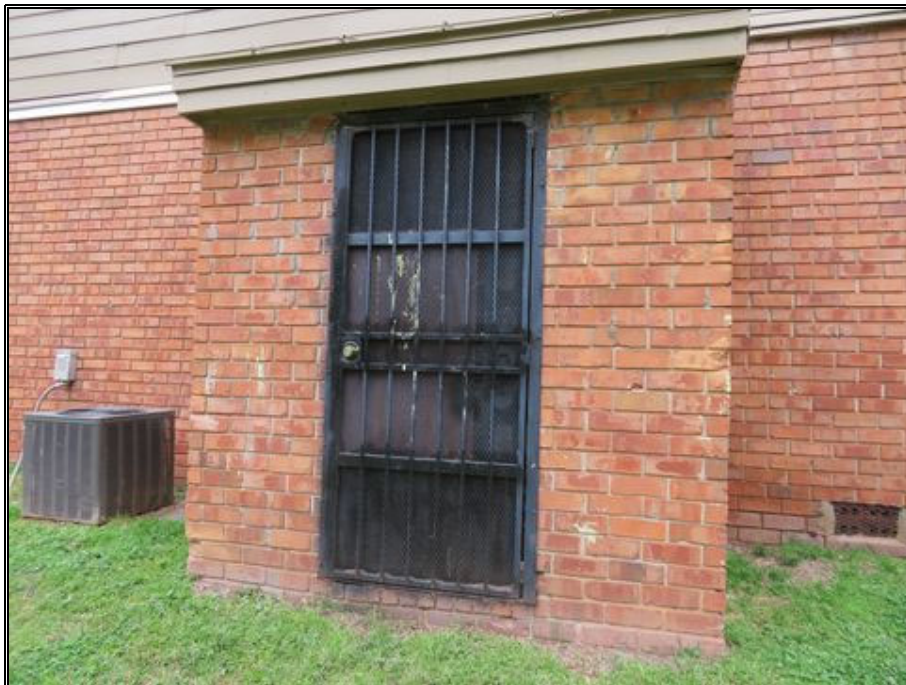
**P12-Typical Electric Meter Room**

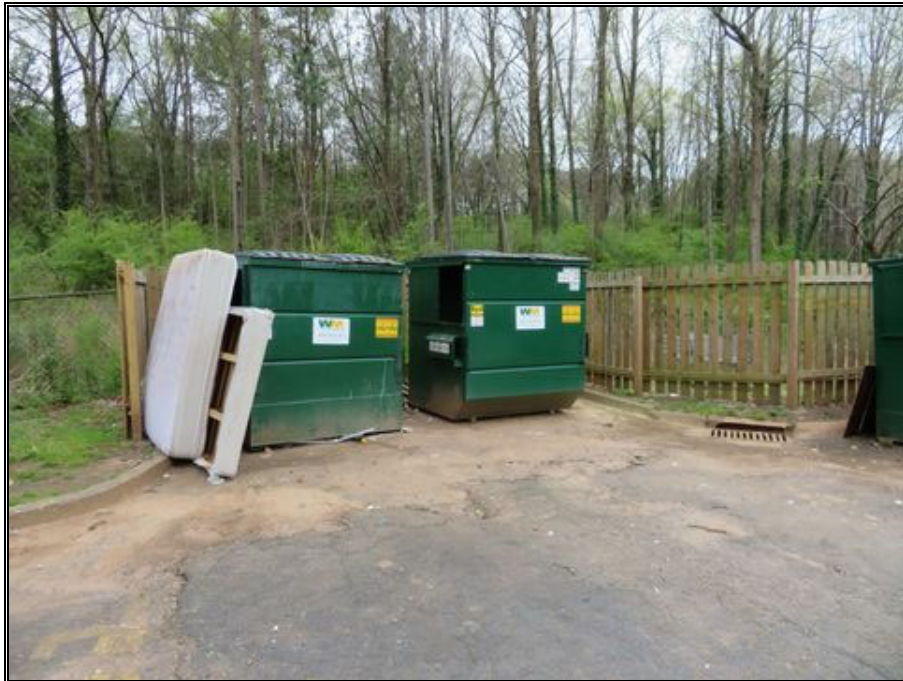
**P14-Typical Dumpster Area/Curb Drain on Right Side**

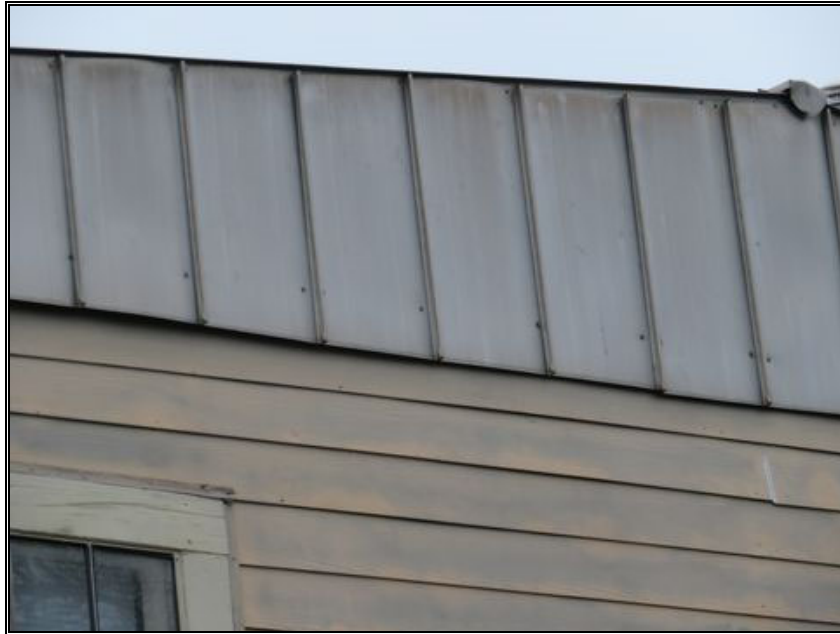
**P17-Metal Gable Area**

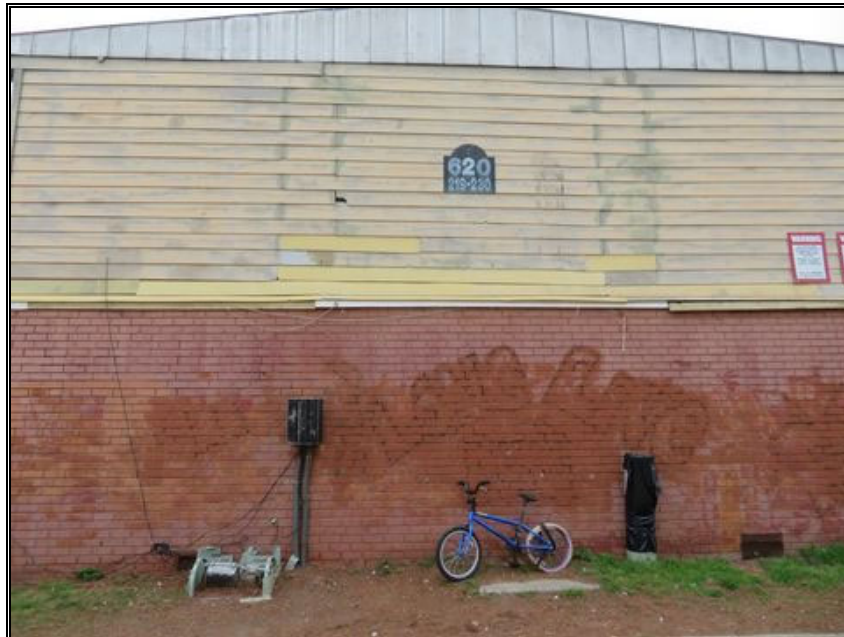
**P18-Typical Condition of End Gable Areas**

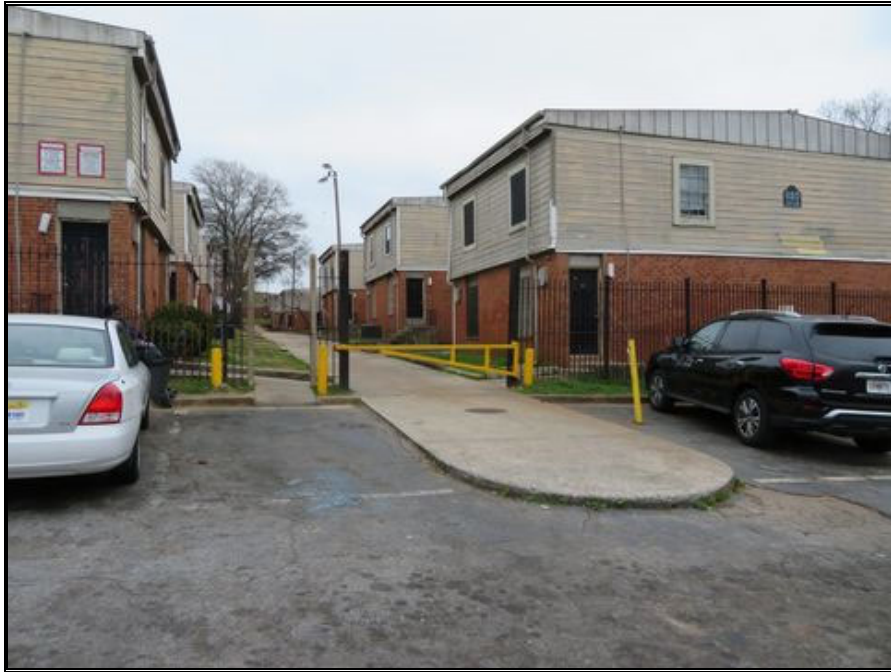
**P25-Gate at Entrance between Buildings**

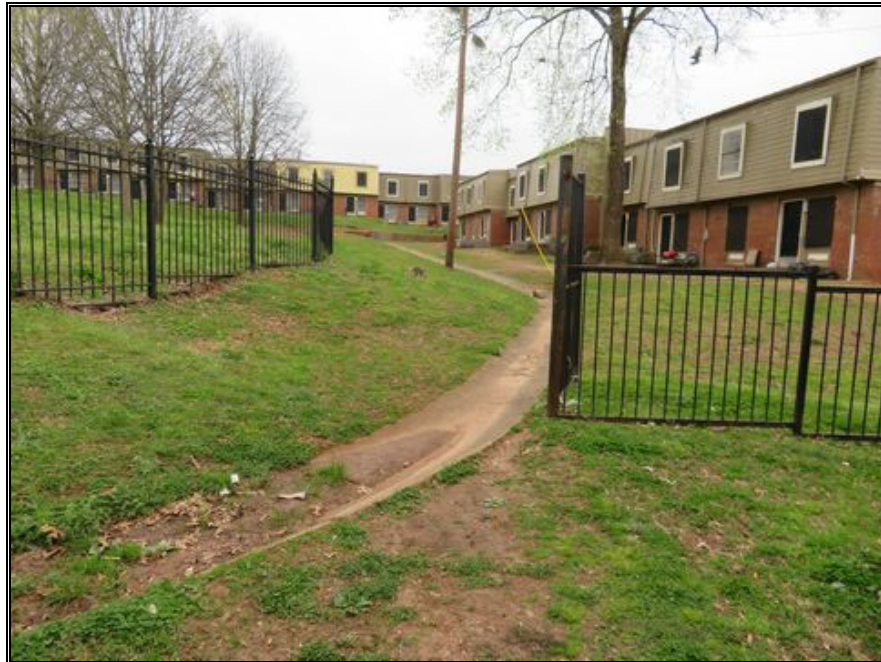
**P26-Typical Concrete Sluceway for Storm Water**

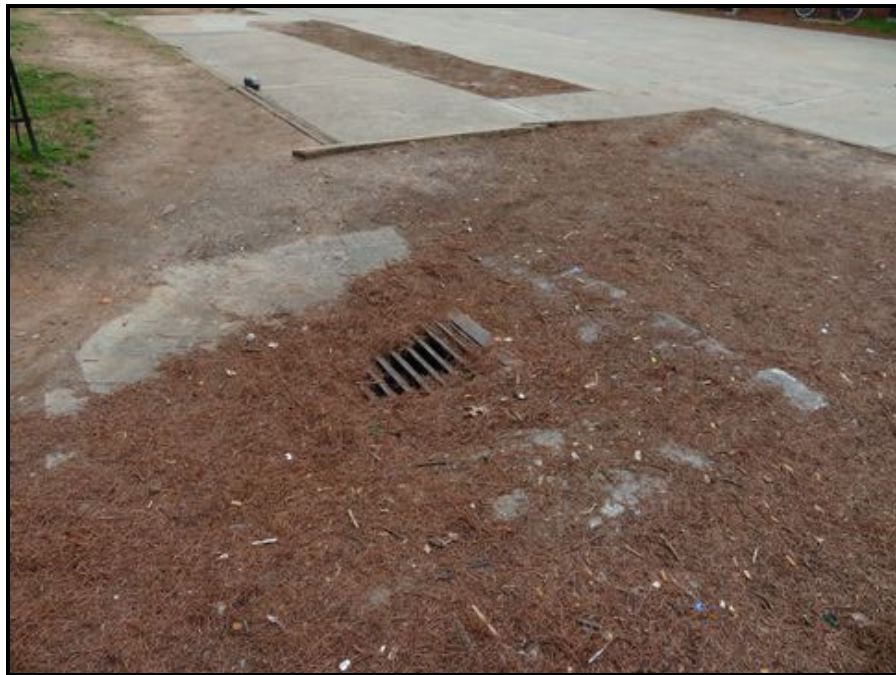
**P28-Typical Yard Drain**

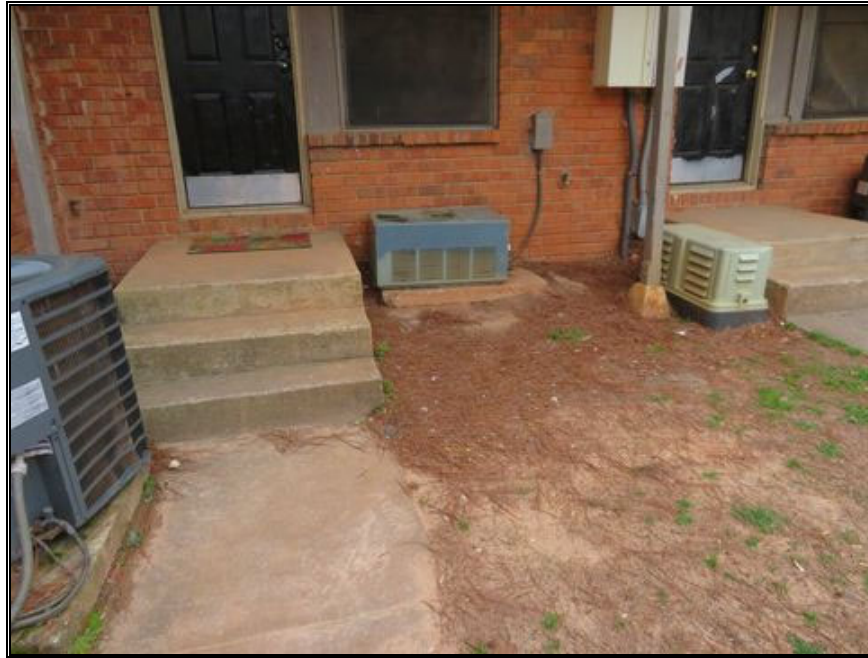
**P29-Typical Air Condensers Variety**

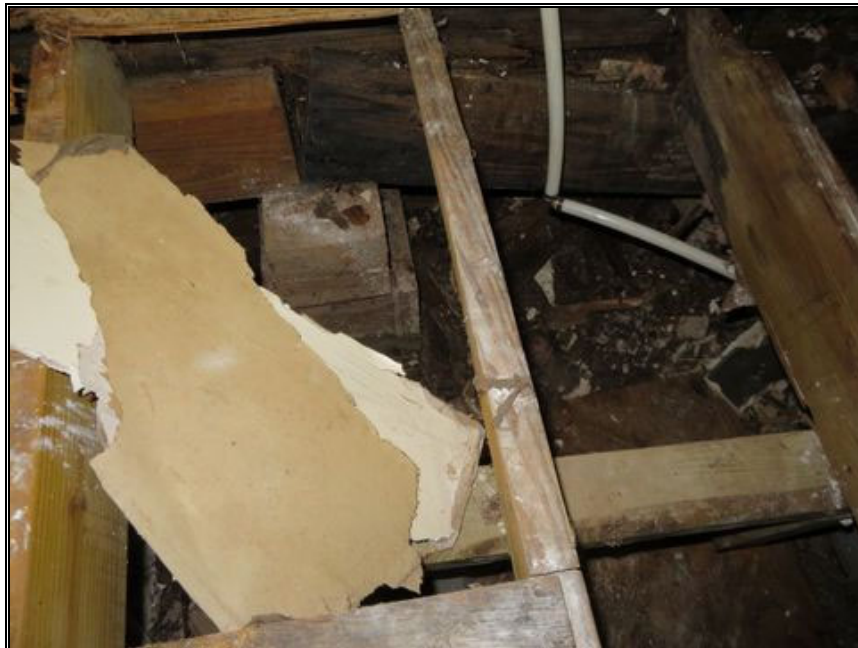
**P30-View of Crawl Space**

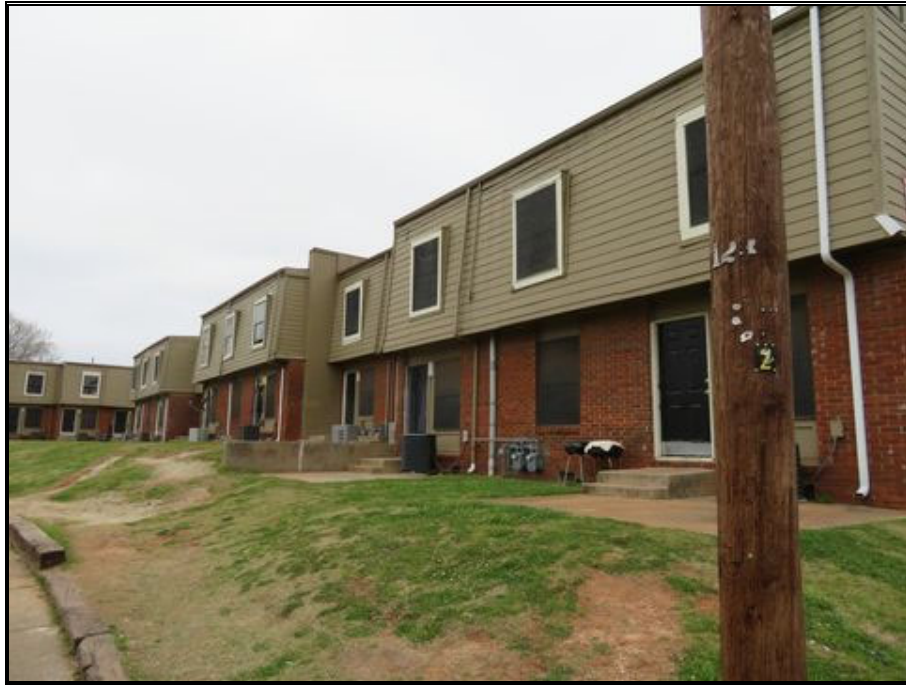
**P33-14-unit Building Rear Elevation**

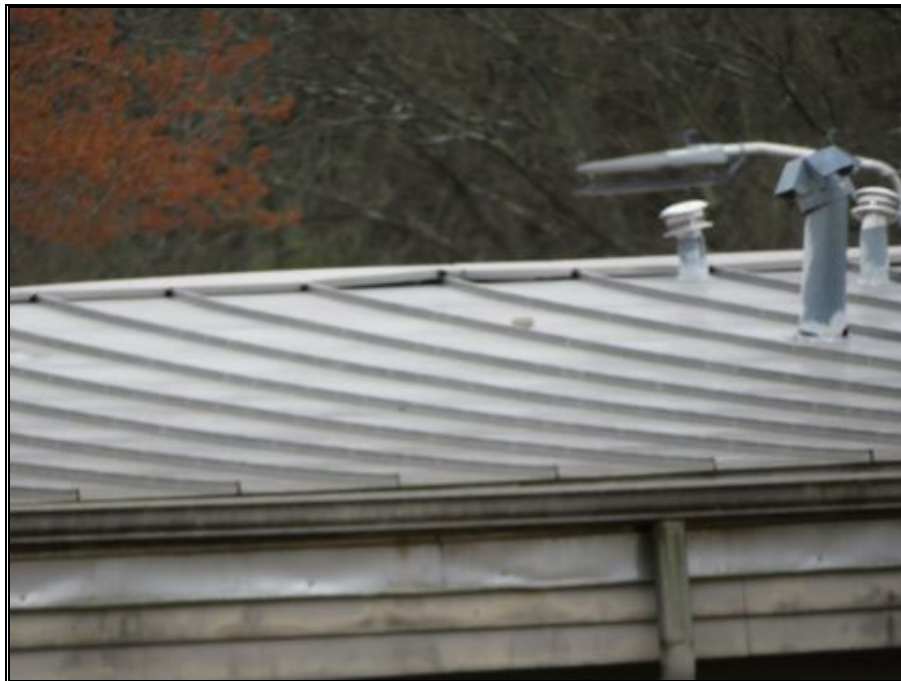
**P34-Typical Steel Roof and Vents Condition**

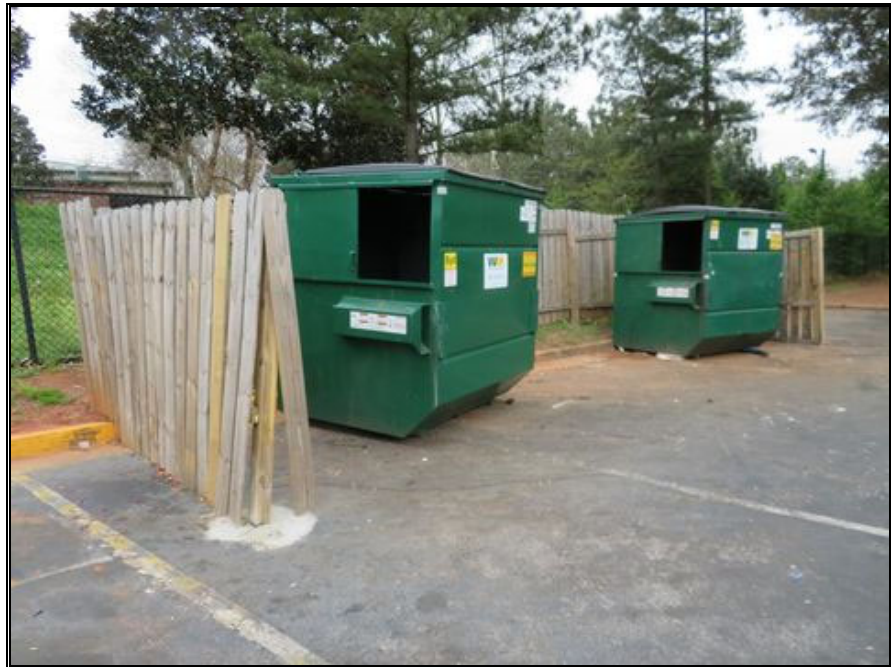
**P36-Dumpster Area with Wood Surrounds in Fair to Poor Condition**

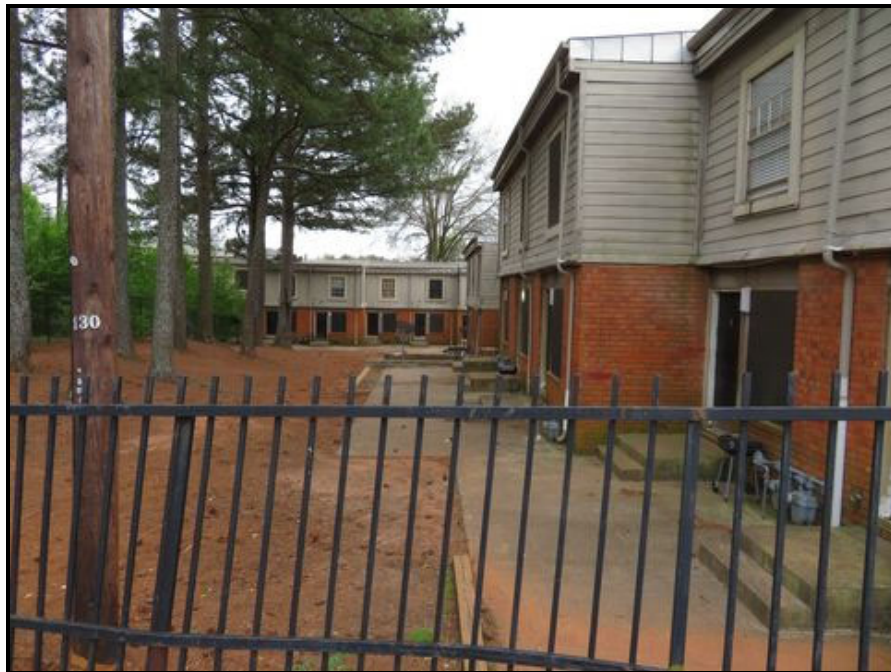
**P38-Fence and Residential Buildings Rear Elevations**

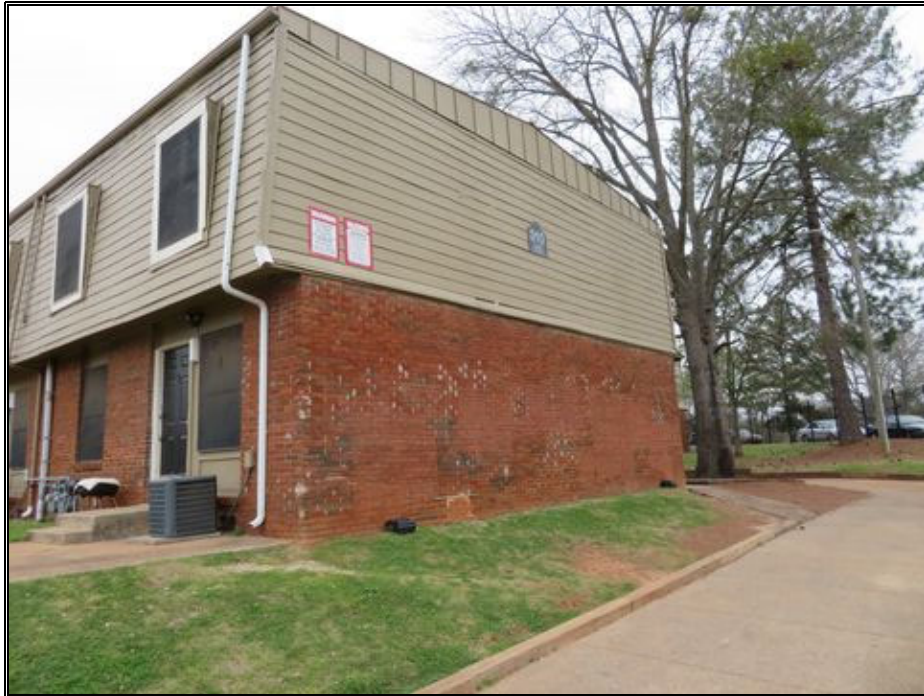
**P39-Residential Building End Elevation Brick Condition**

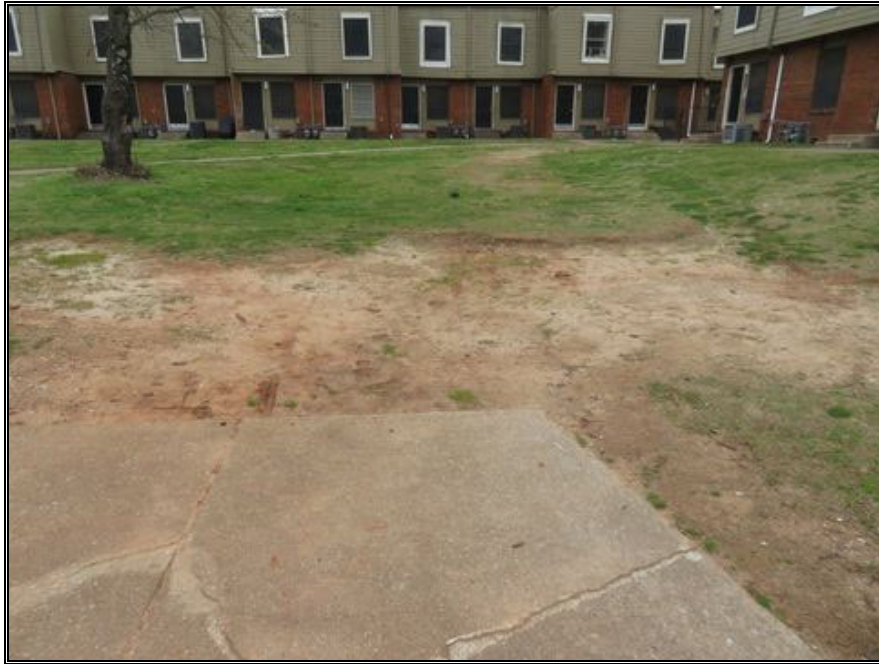
**P43-Example of Erosion on the Property**

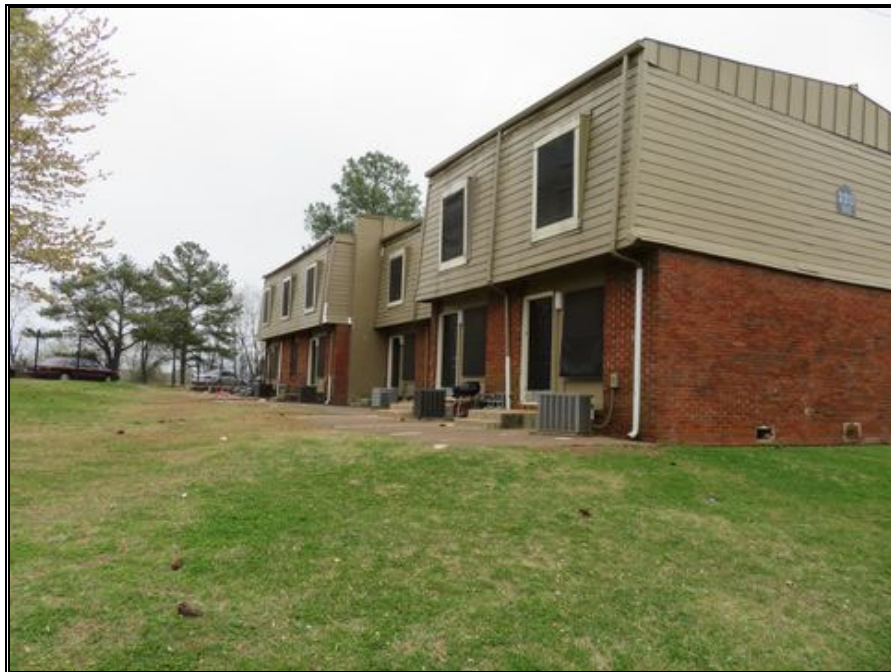
**P47-Typical Courtyard Area (Former Parking Area)**

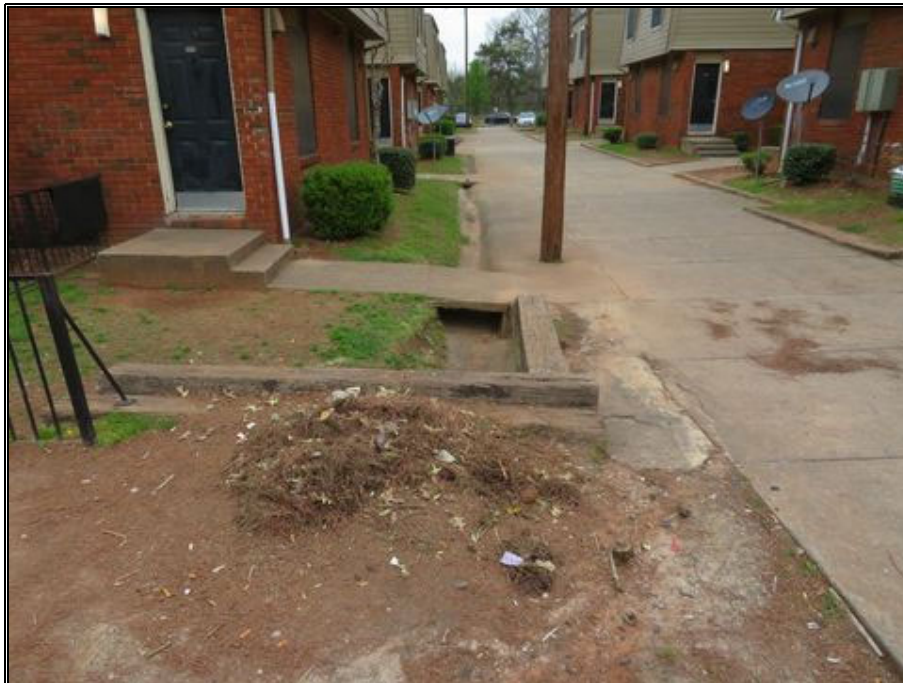
**P49-Sidewalk Area (Previous Used as a Driveway)**

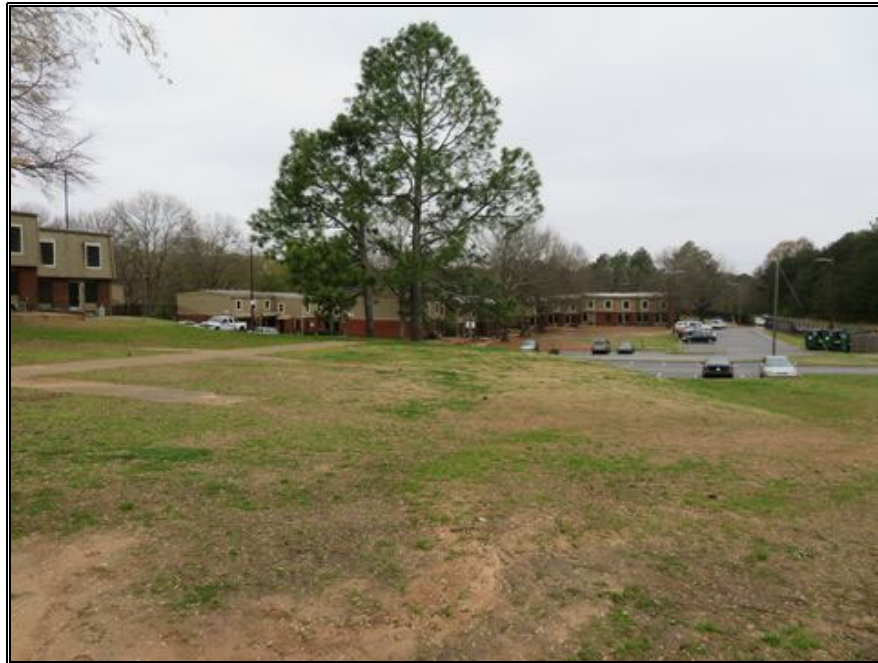
**P51-Building Rear Elevation/Eroded Hillside**

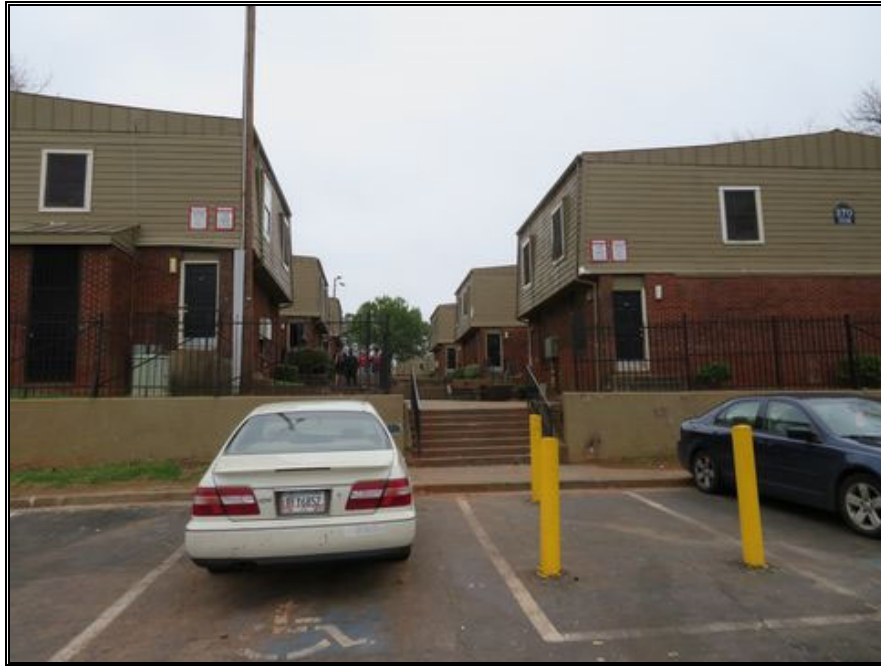
**P52-View of West Side of South Section**

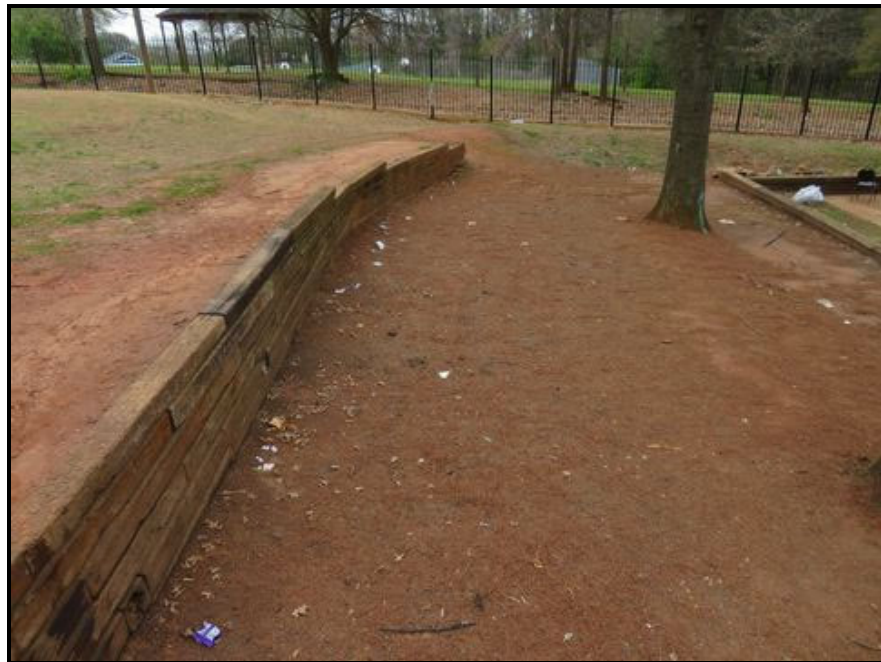
**P53-Retaining Wall/Stair Sets**

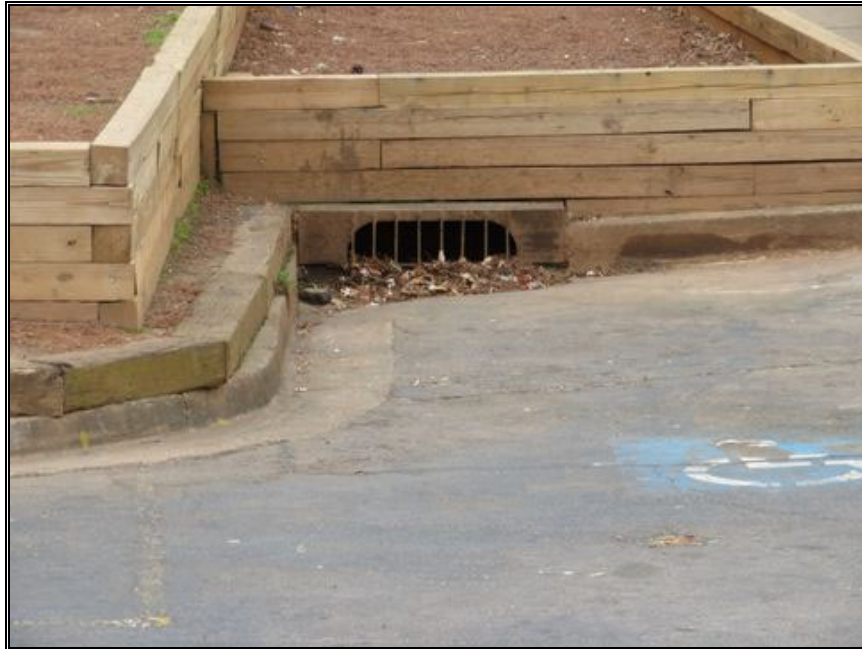
**P56-South Section Parking Area**

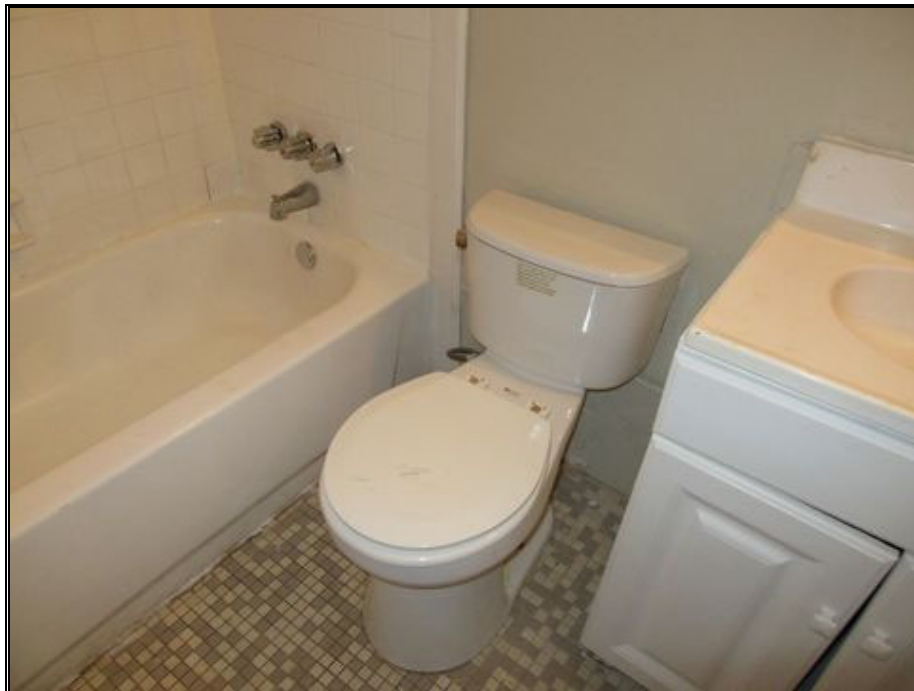
**P71-Vacant Unit Bathroom (Poor Vanity)**

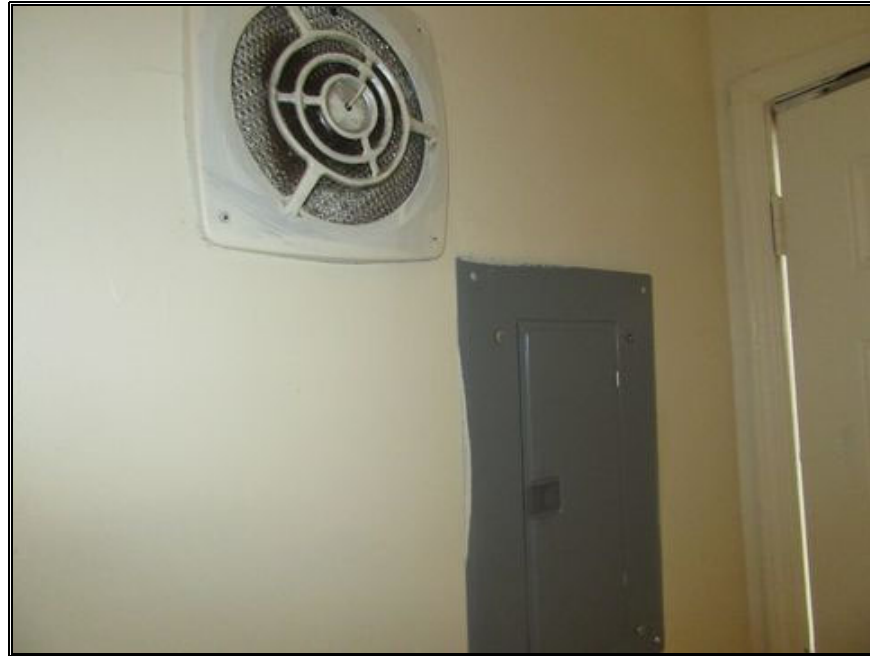
**P80-Typical Apartment Panel Box**
