# **COMPREHENSIVE NEEDS ASSESSMENT**

**ABLE Apartments  
1000 Any Street  
Atlanta, Georgia**

**ALCA Associates  
520 South State Street  
Westerville, OH 43081  
Office: (614) 794-4900**

**XYZ Companies**

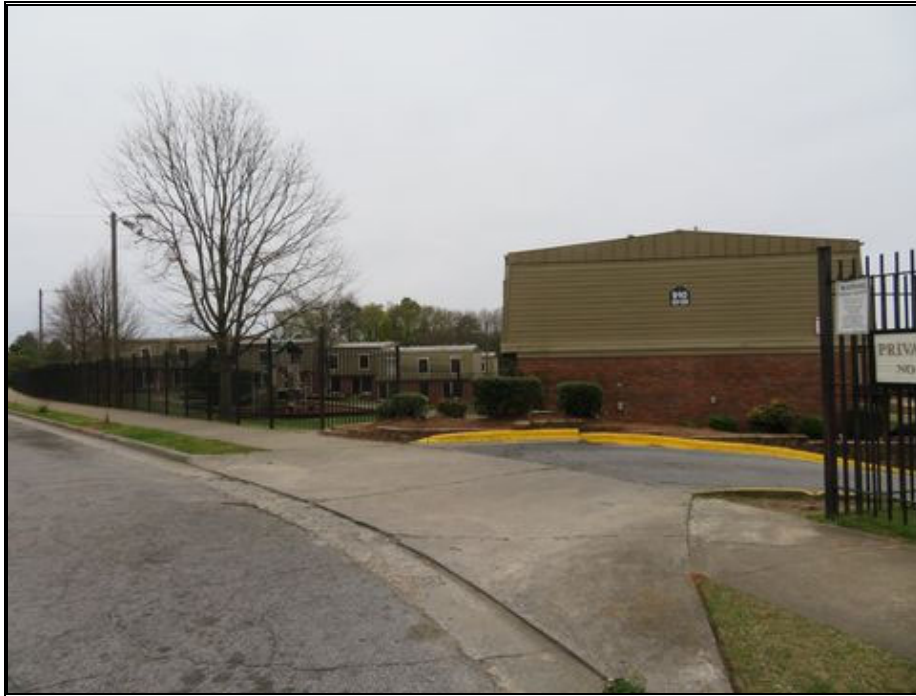
**P3-Property View North Side at Entrance**

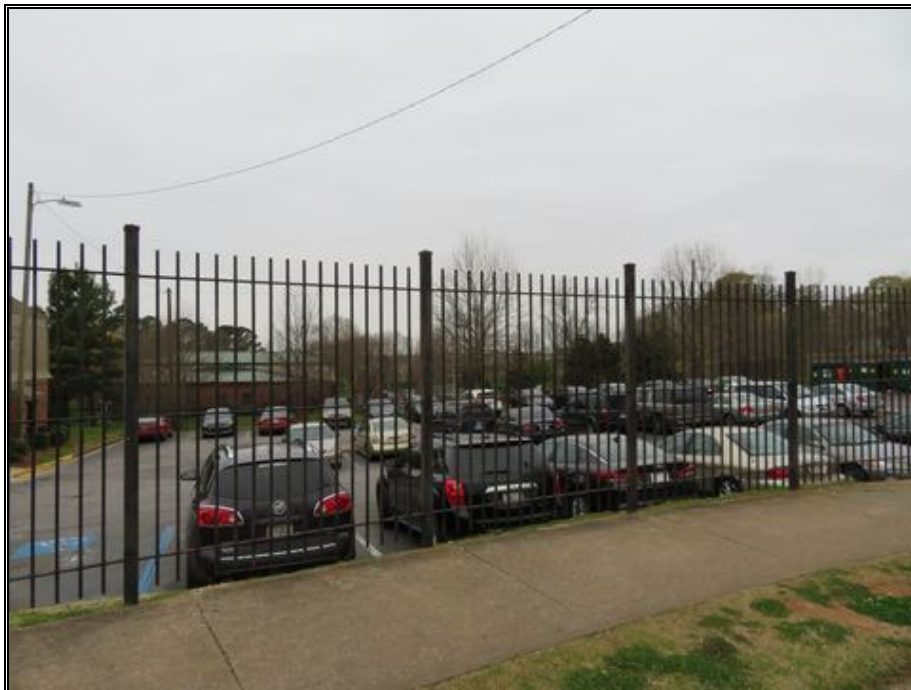
**P4-Parking Lot at Office**

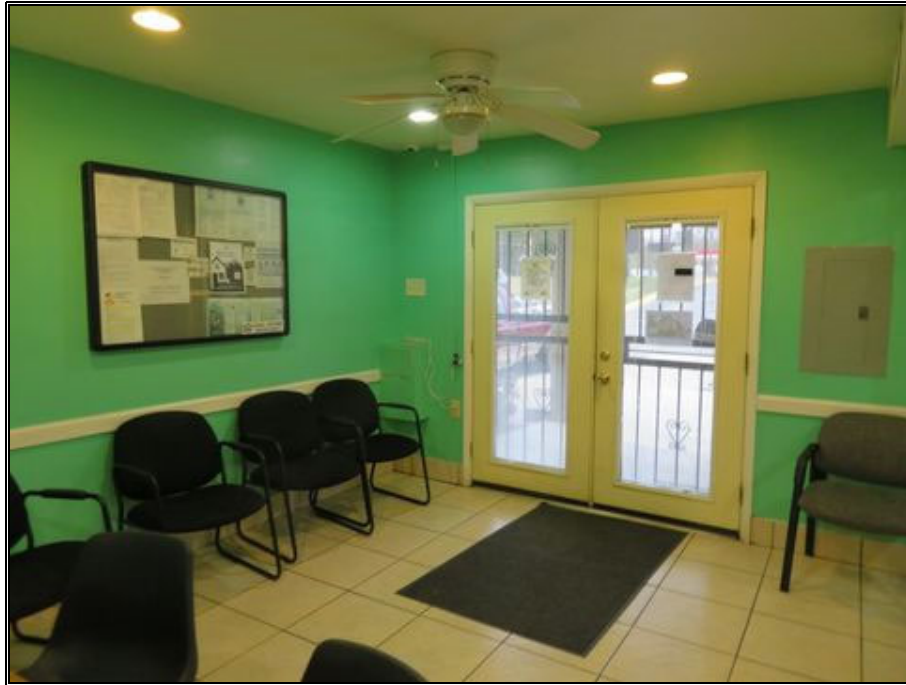
**P5-Office Entrance**

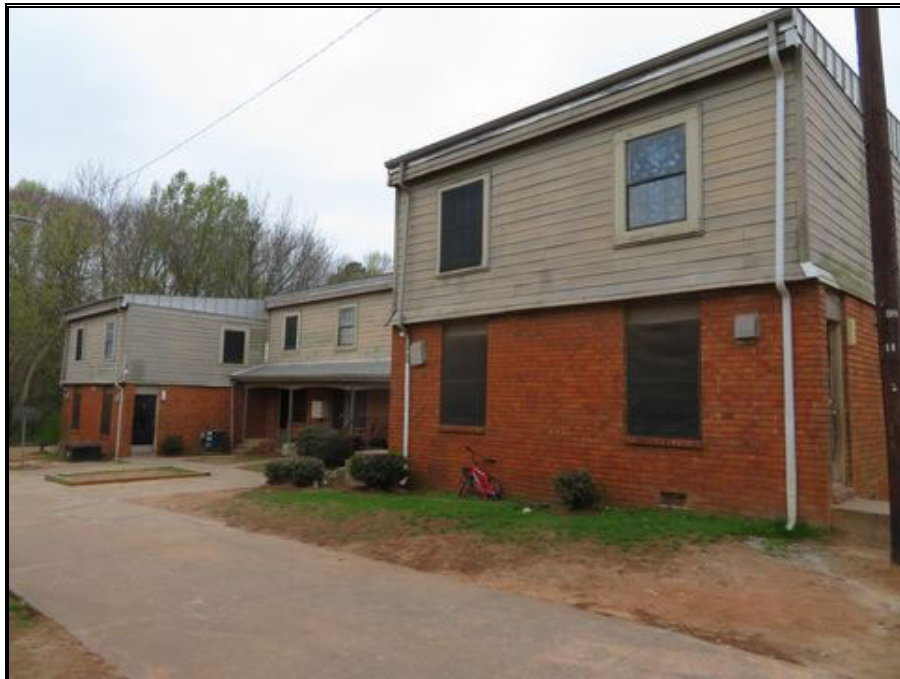
**P6-Residential Building Front Elevation**

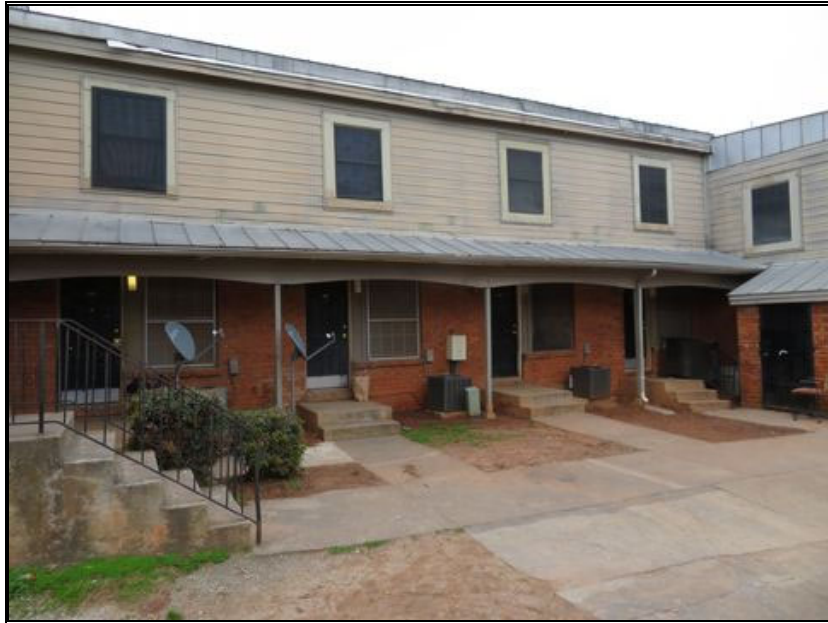
**P7-Residential Building Front Elevation**

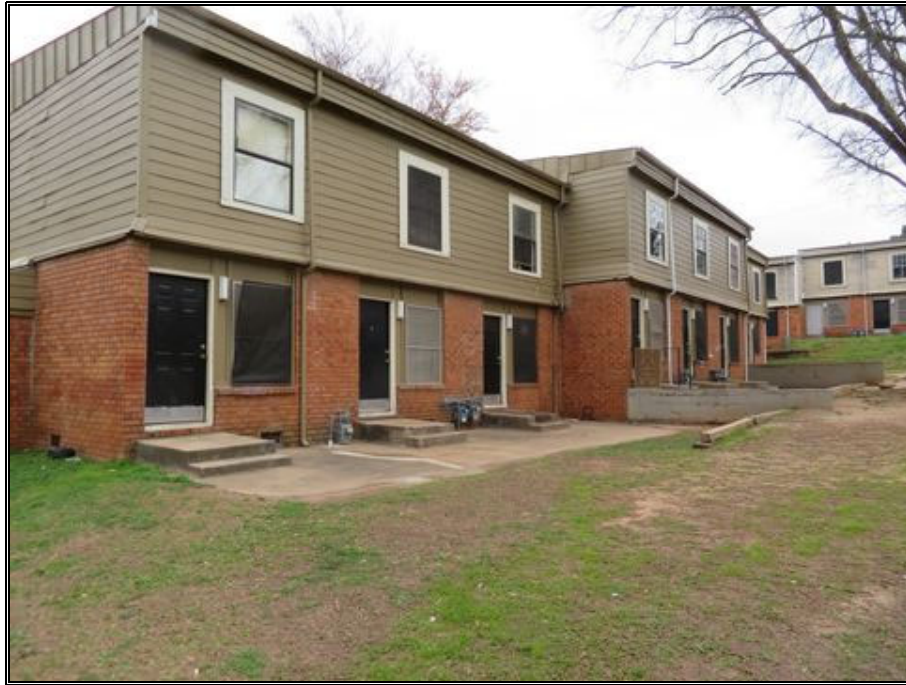
**P11-Stepped Building Rear Elevation**

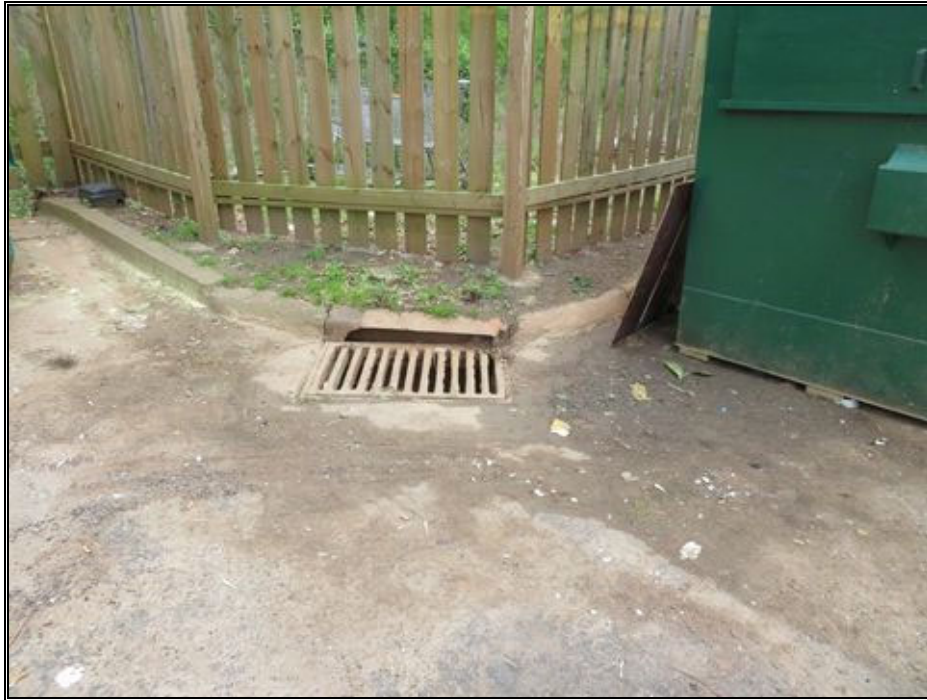
**P15-Typical Curb Drain**

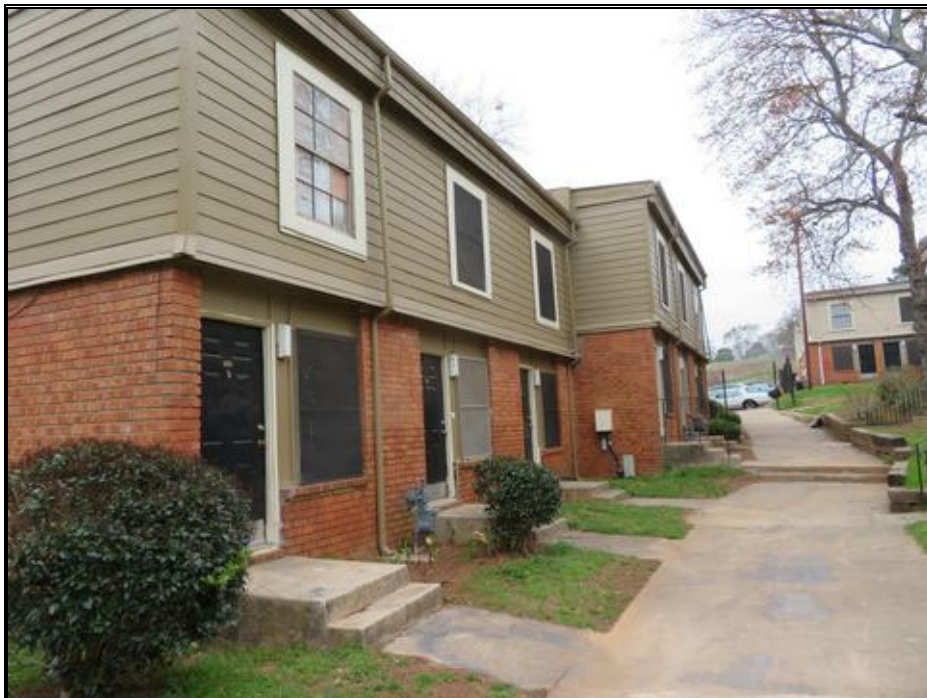
**P16-Stepped Building Front Elevation**

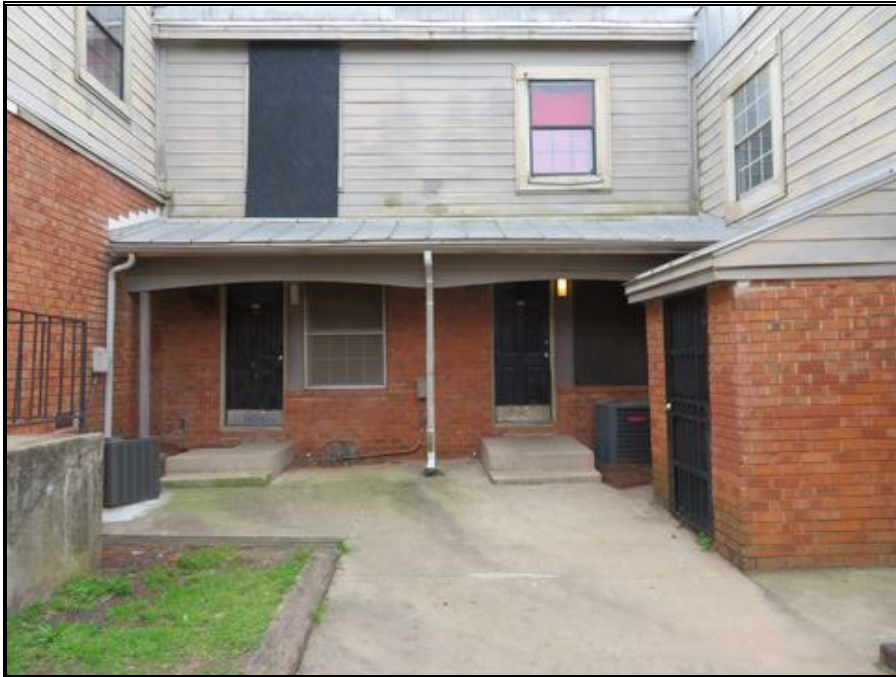
**P19-Typical Courtyard with Apartment Entrances**

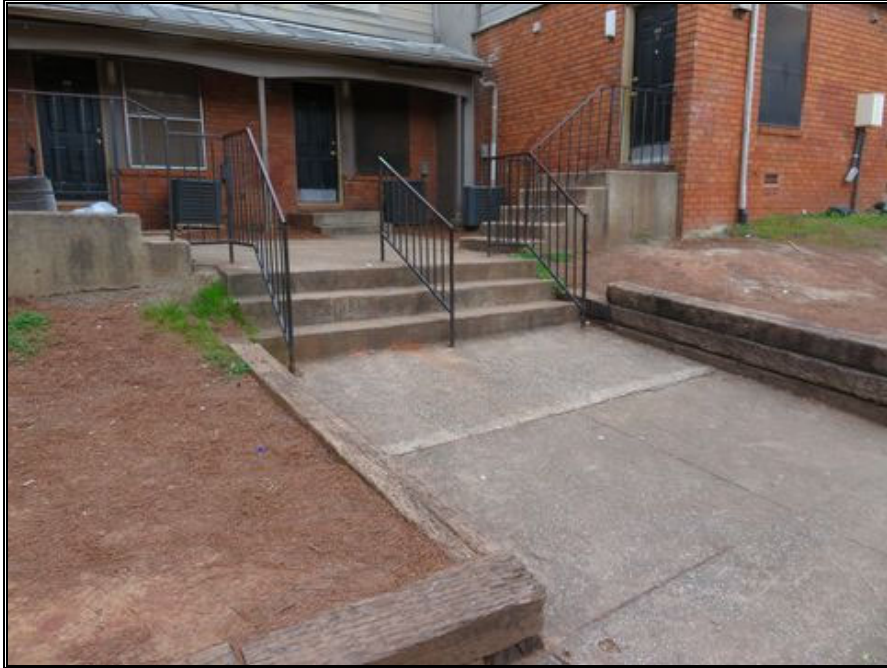
**P21-Dwelling Units with Stair and Step Engrances**

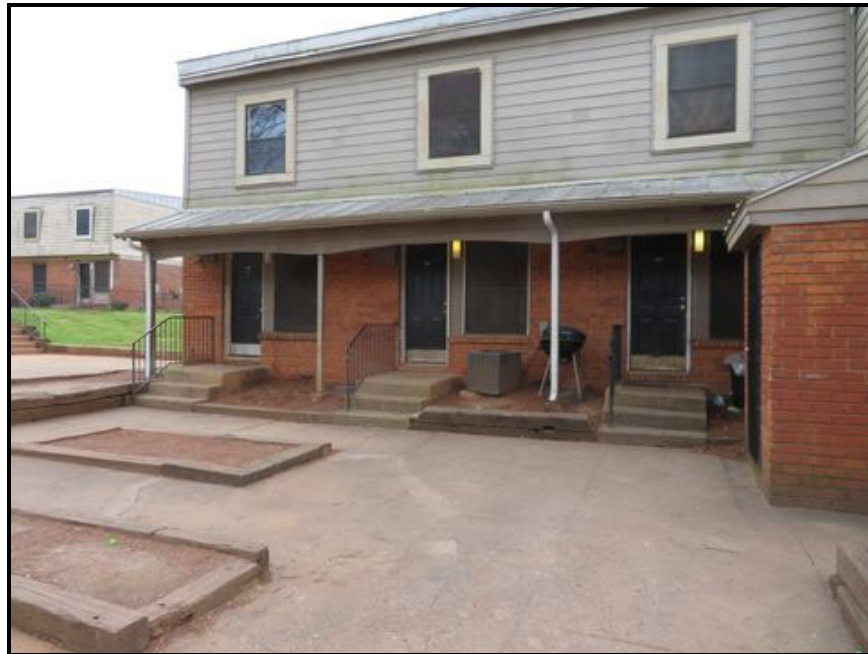
**P22-End Dwelling Units with Stoops and Railings**

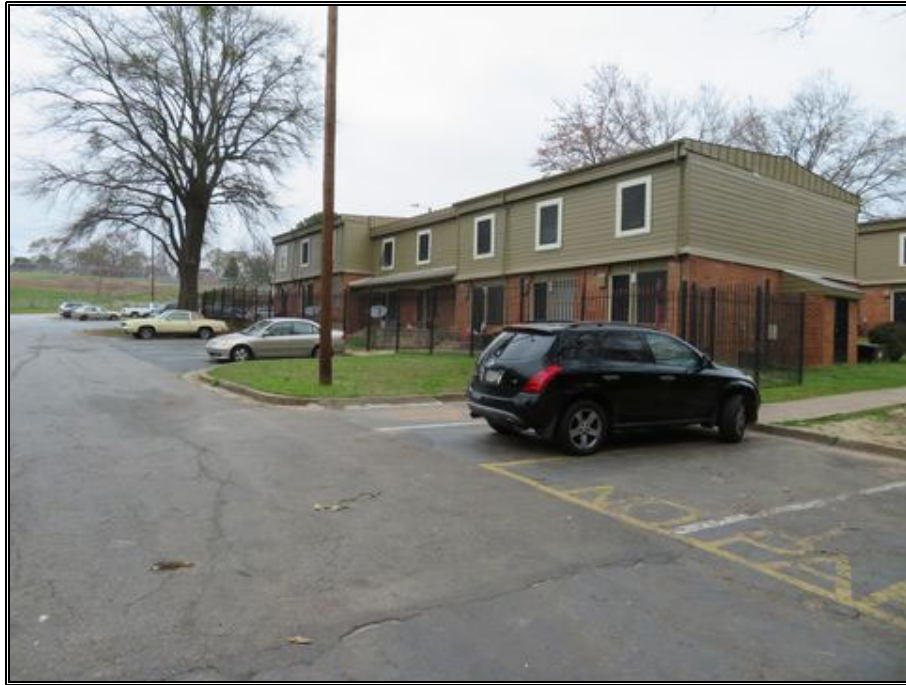
**P23-Parking Area/Metal Fencing/Building Elevation**

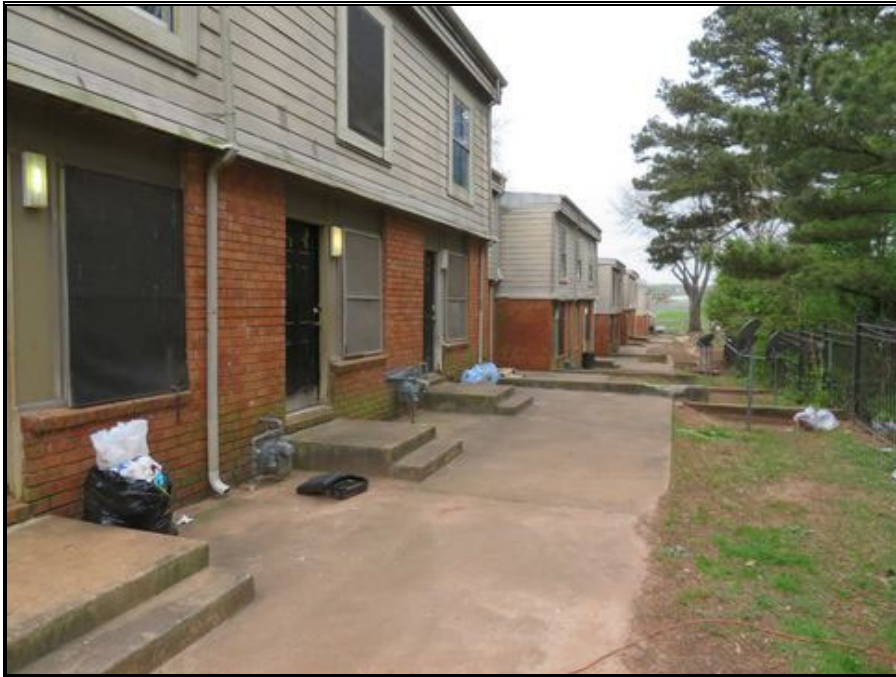
**P27-Stepped Down Buildings Rear Elevations**

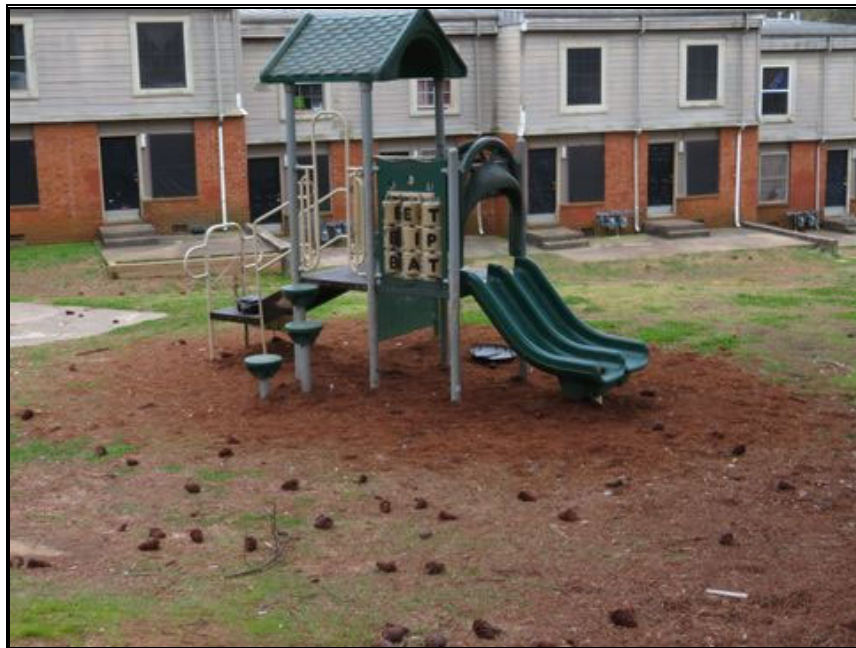
**P32-Playground Area**

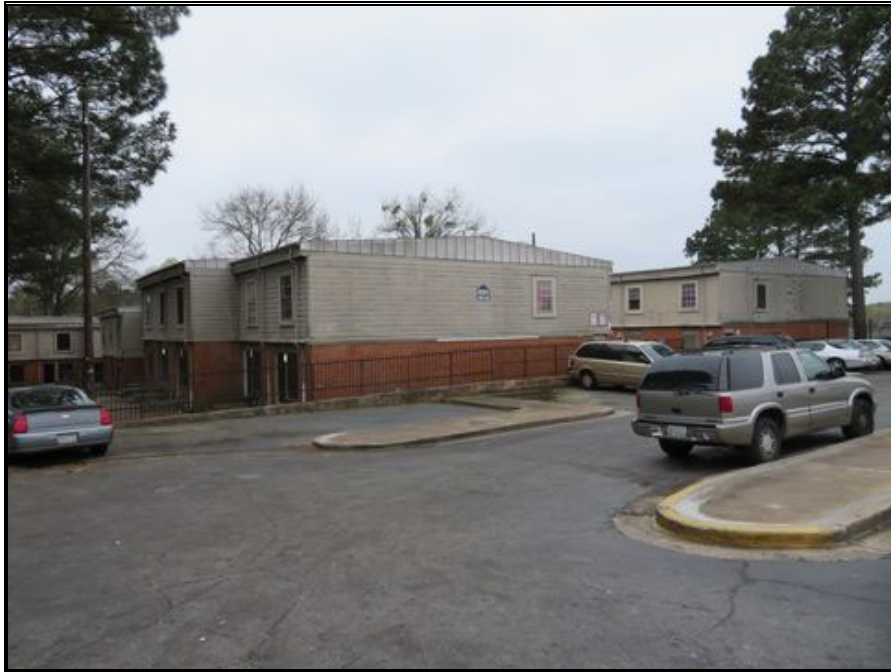
**P35-End Views of Residential Buildings**

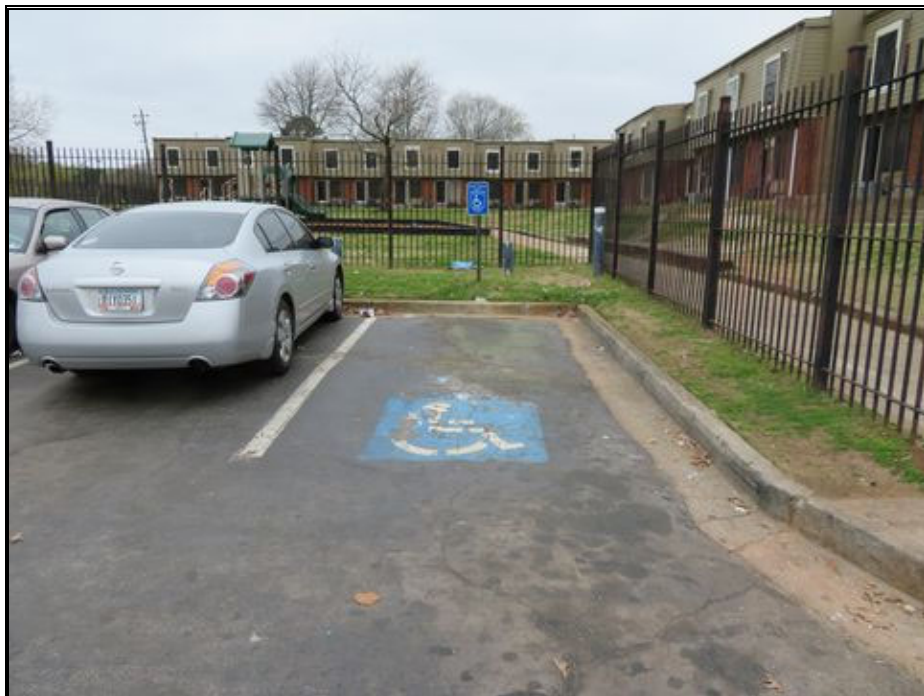
**P40-Steel Fence/HC Parking Space**

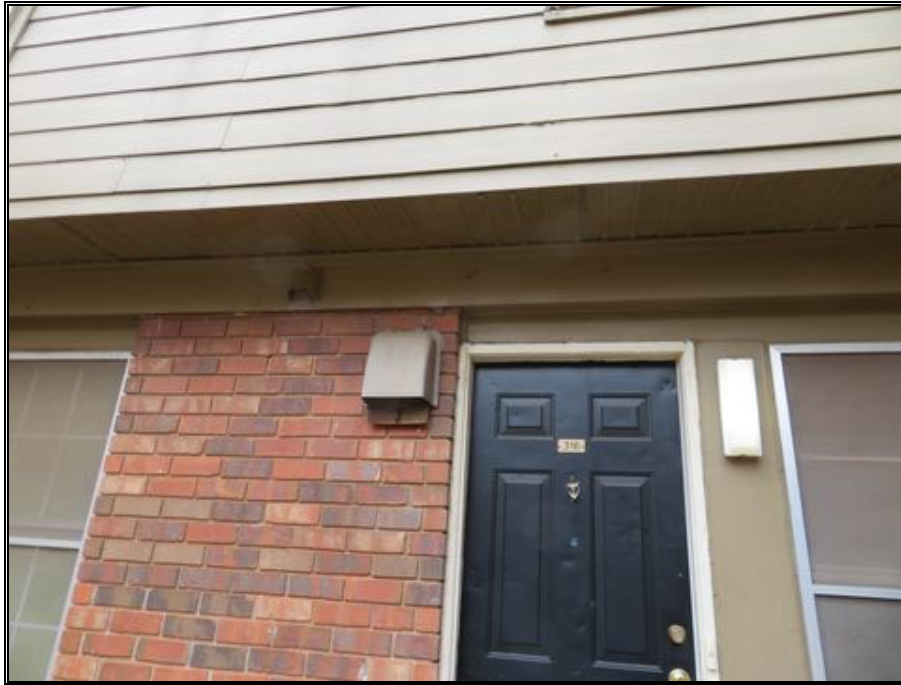
**P41-Townhouse Entry Door**

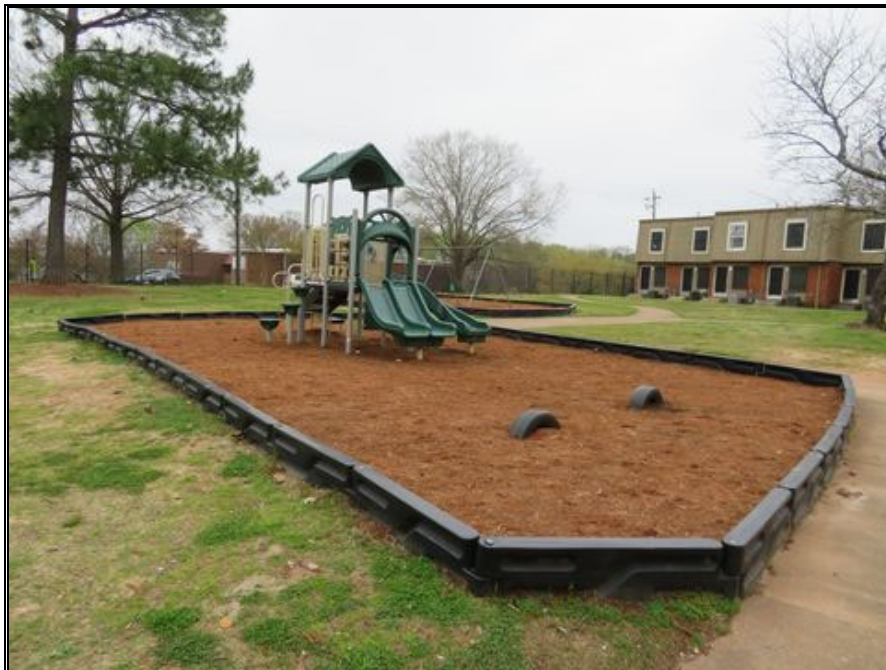
**P42-Playground Area**

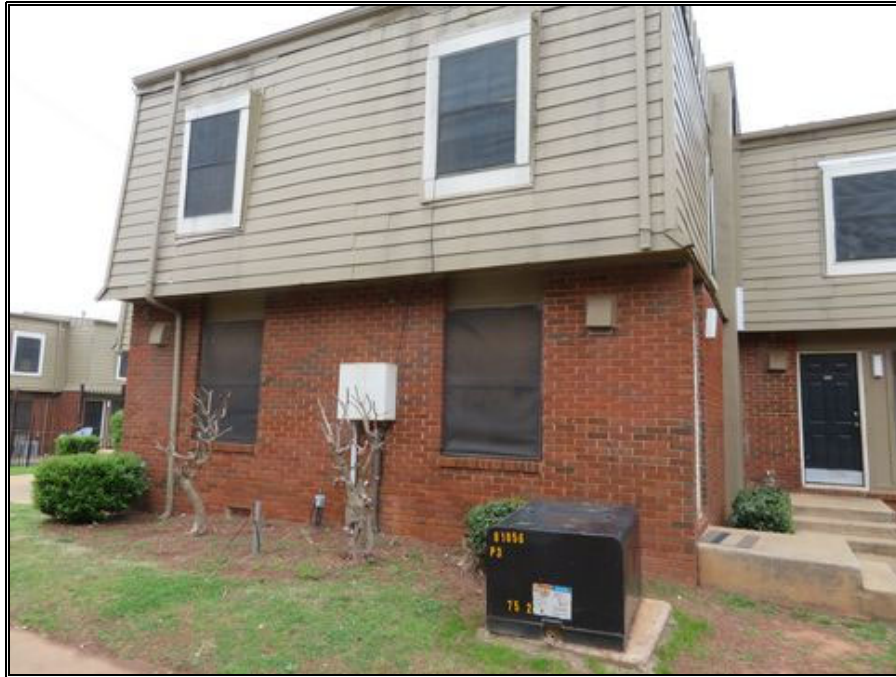
**P45-Ground Transformer**

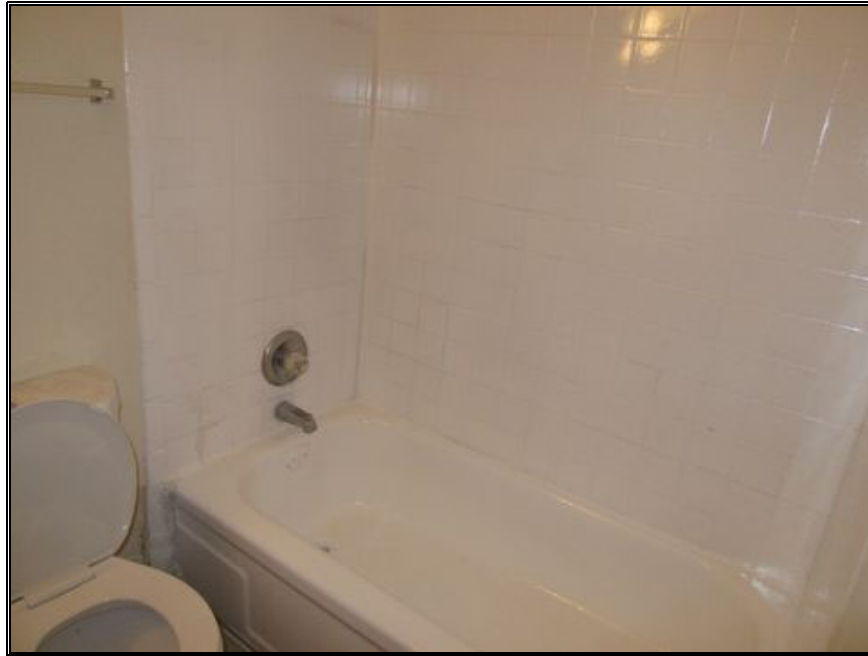
**P62-Vacant Unit Bathroom**

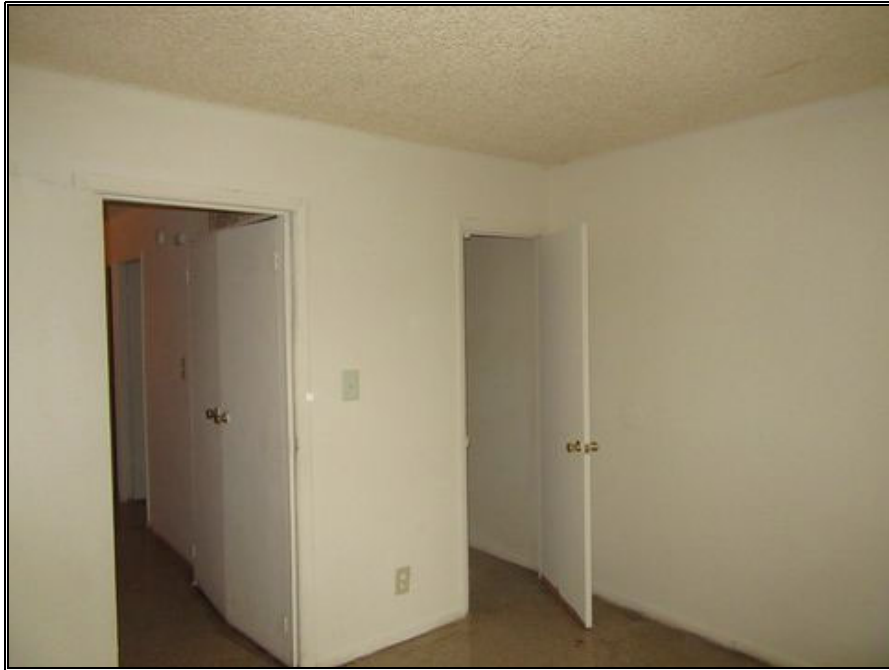
**P66-Vacant Townhouse Second Floor**

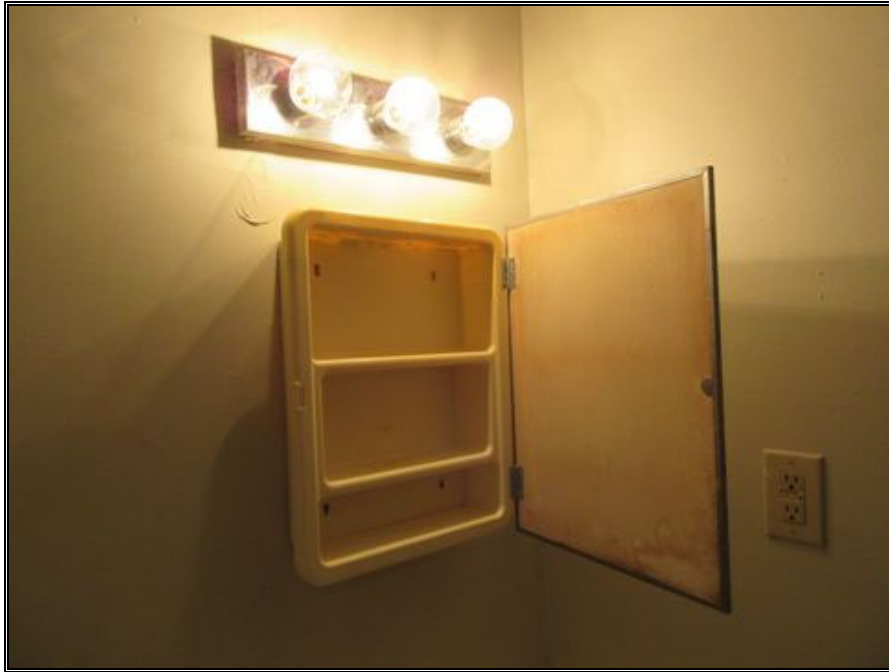
**P72-Vacant Unit Bathroom**

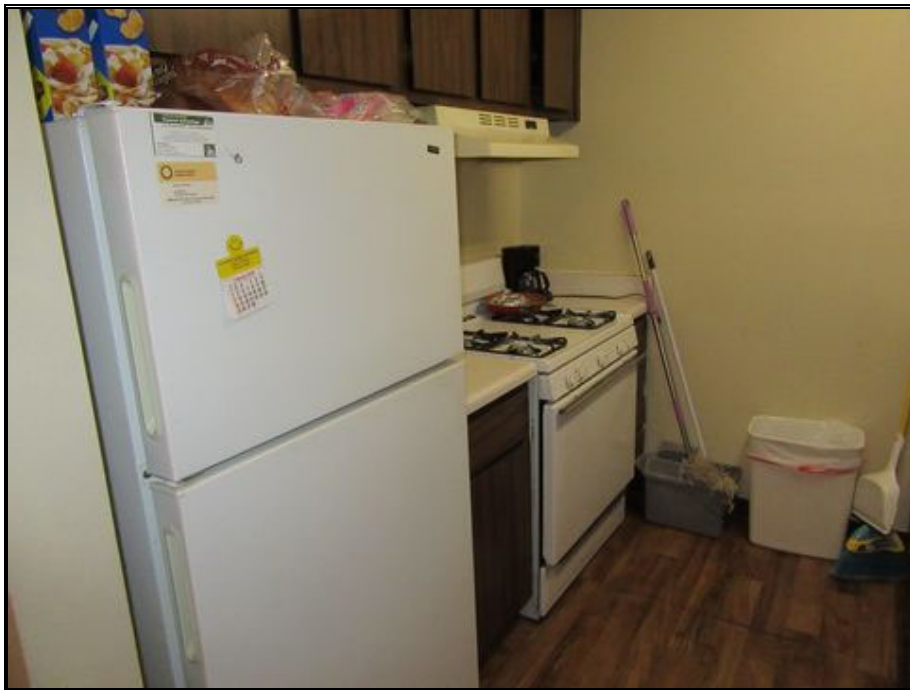
**P77-Occupied Unit Kitchen**

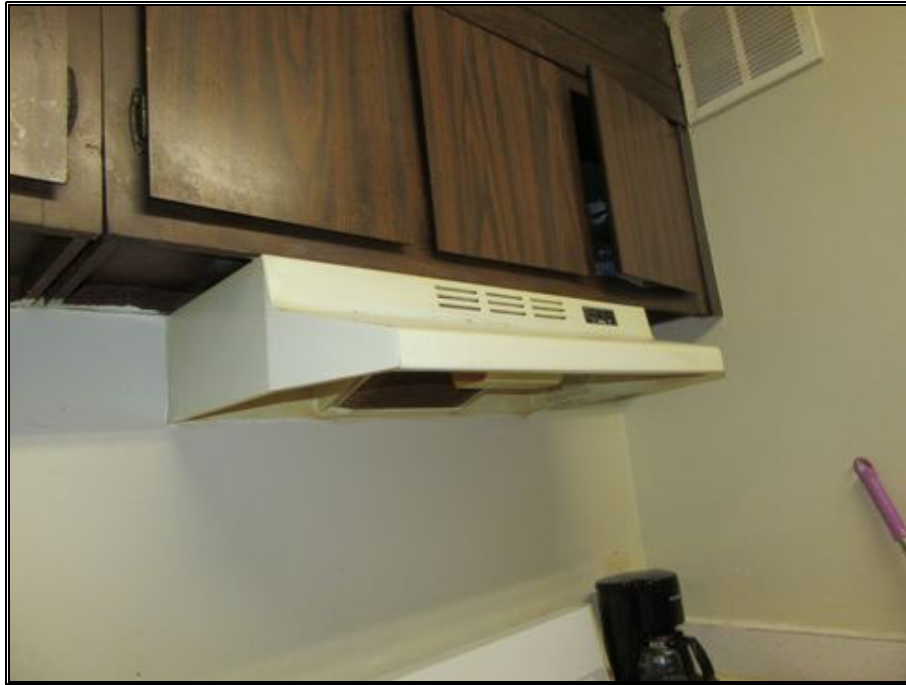
**P78-Occupied Unit Kitchen**

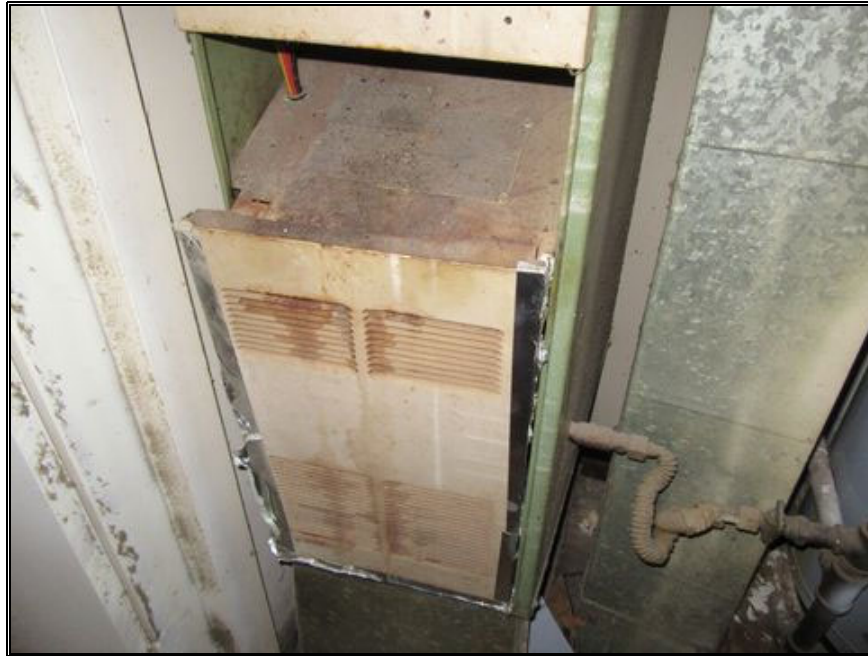
**P86-Townhouse Stair Set**
